Preparation of drawings and specifications for mitigation of earthquake damage to five  
County Library buildings:

Weber County Main Library;  
Weber County North Branch;  
Weber County Ogden Valley Branch;  
Weber County Pleasant Valley Branch; and  
Weber County Southwest Branch/Headquarters.

## **EARTHQUAKE DAMAGE ASSESSMENT**

**RE:** Earthquake Damage Observation for the Main Library

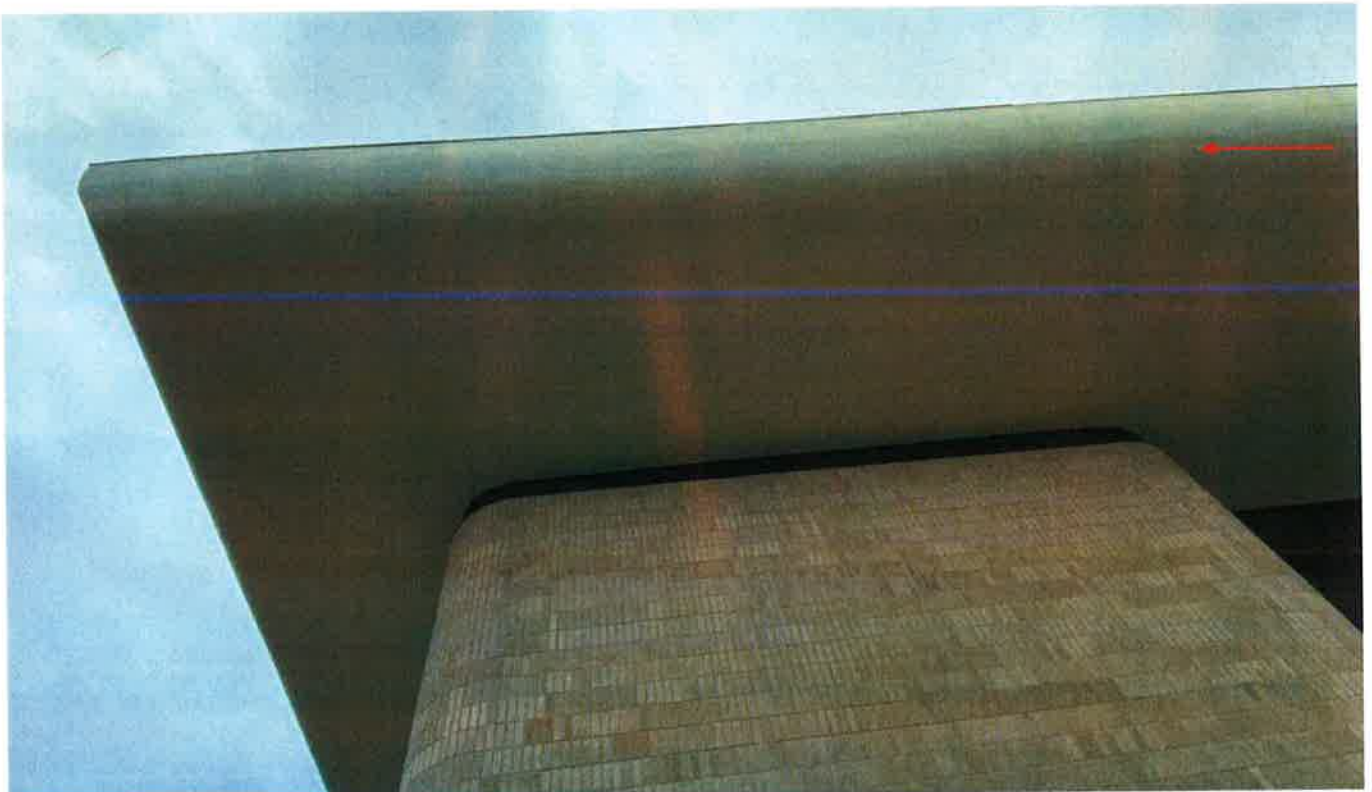
Image 1. At all 4 sides of the building facades, the Plaster soffit exhibits several hairline cracks. This soffit overhangs the public walkways.

#1. Plaster Soffit hairline cracks

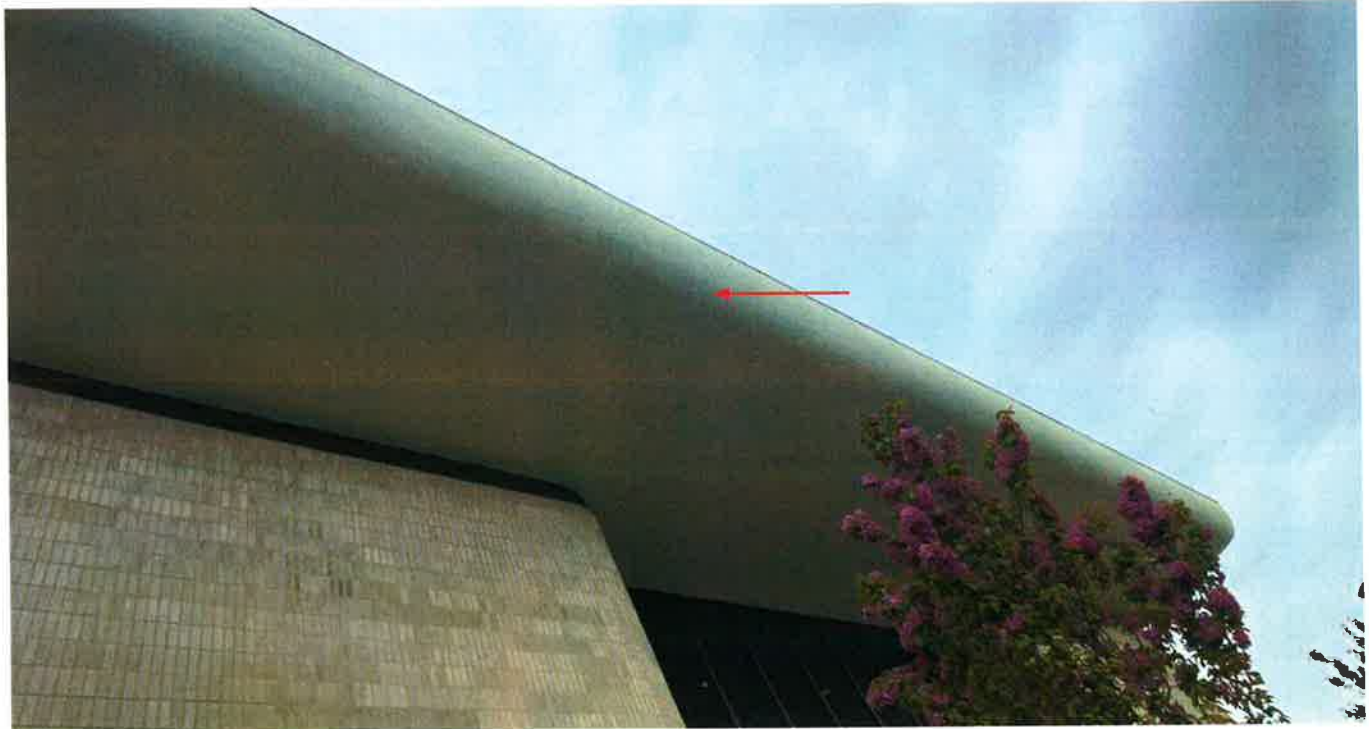
#1. Plaster Soffit hairline cracks

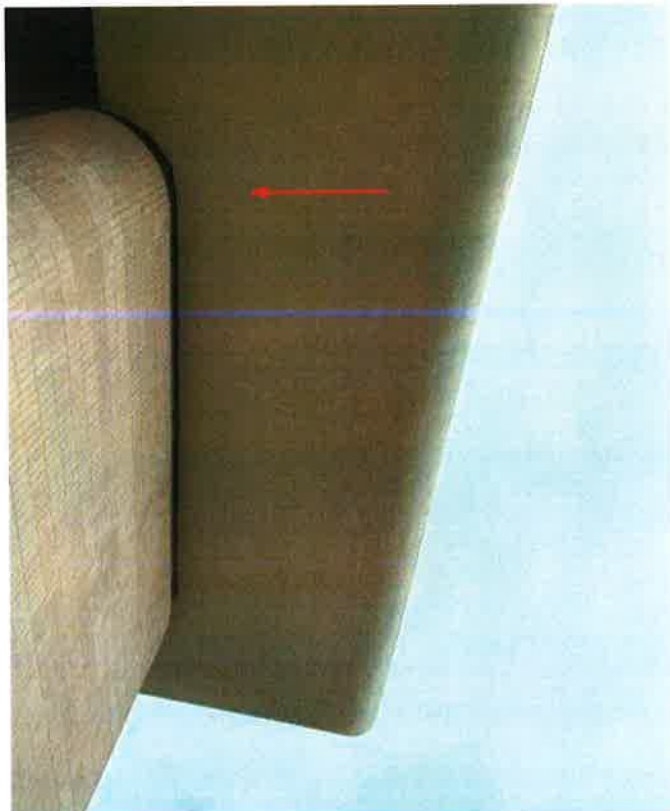
#1. Plaster Soffit hairline cracks

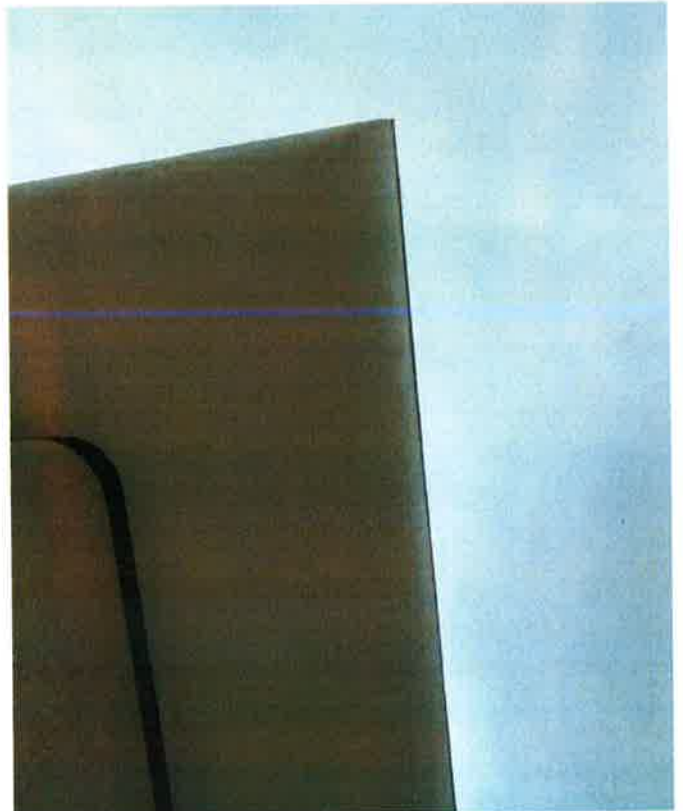
#1. Plaster Soffit hairline cracks

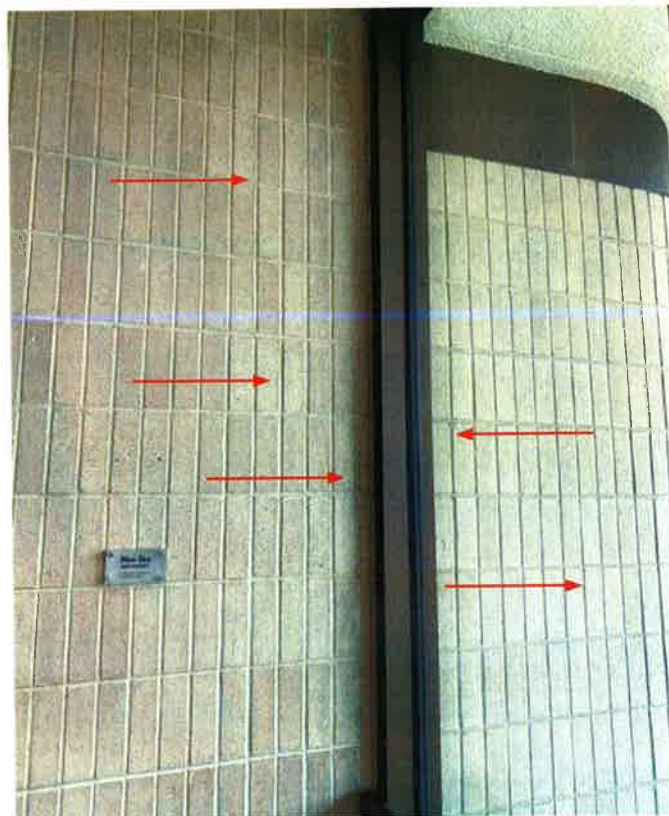
Image 2. On level 2, at several locations along the exterior walls, the exterior brick masonry exhibits cracks along the mortar joints on several areas. This is visible though the glass on the exterior face of the building but also as the brick masonry returns into the building. We photographed many of these instances, but there may be areas out of view that need to be accessed with a lift for better visibility. These cracks could carry moisture from the outside of the building into the wall assembly if left un-addressed.

#2. Brick masonry joint cracking on level 2.

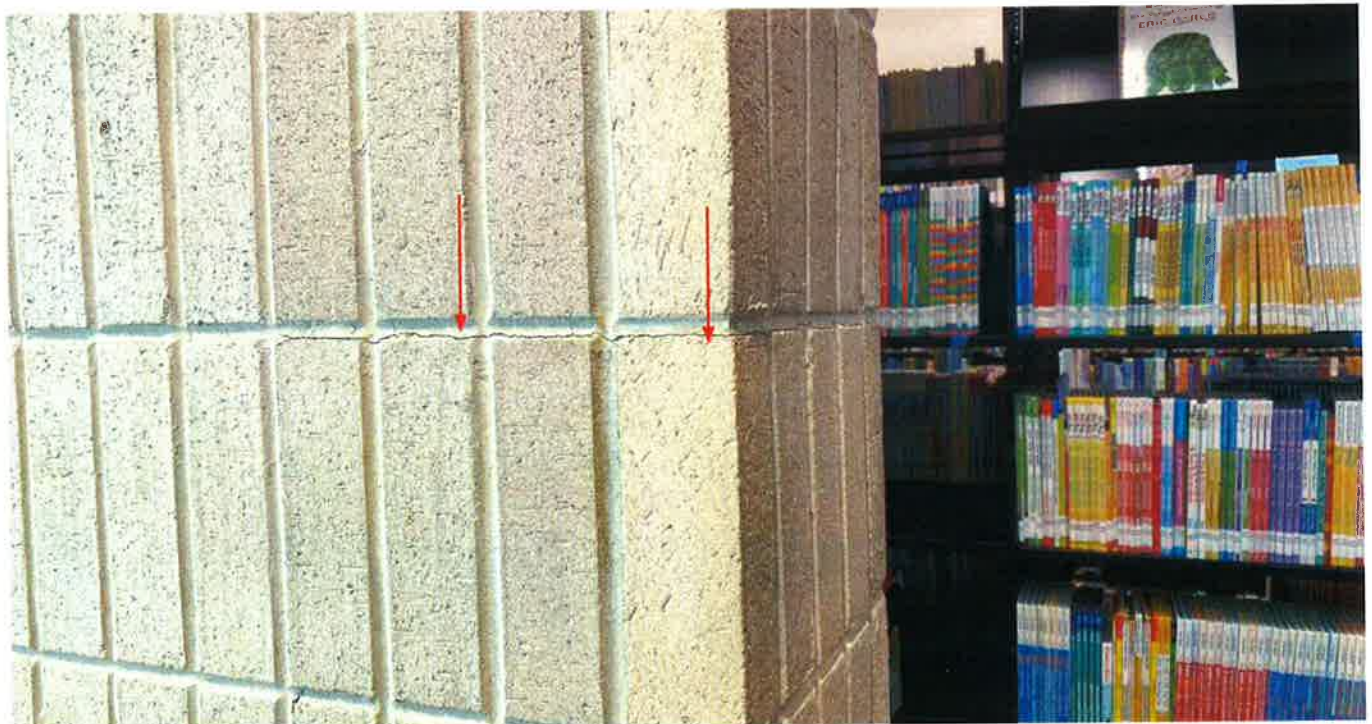
Image 3. The North end of the building on level 2 exhibits several items that experienced recent movement: Plaster soffit cracks, separation of the ceiling from the wall and cracked masonry joints. We photographed these items, but did not access above the ceilings space.

#3. Ceiling separation from wall

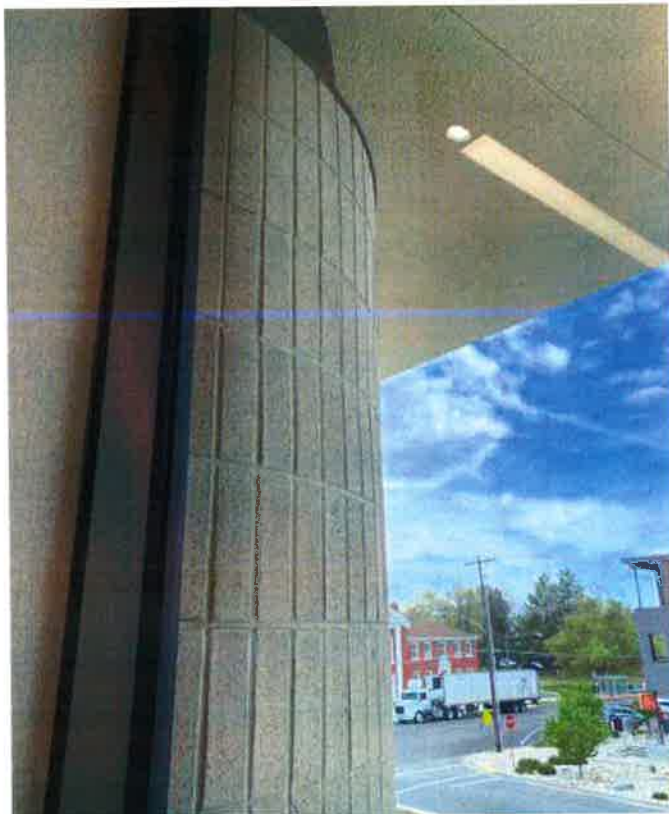
#2. Brick masonry joint cracking on level 2

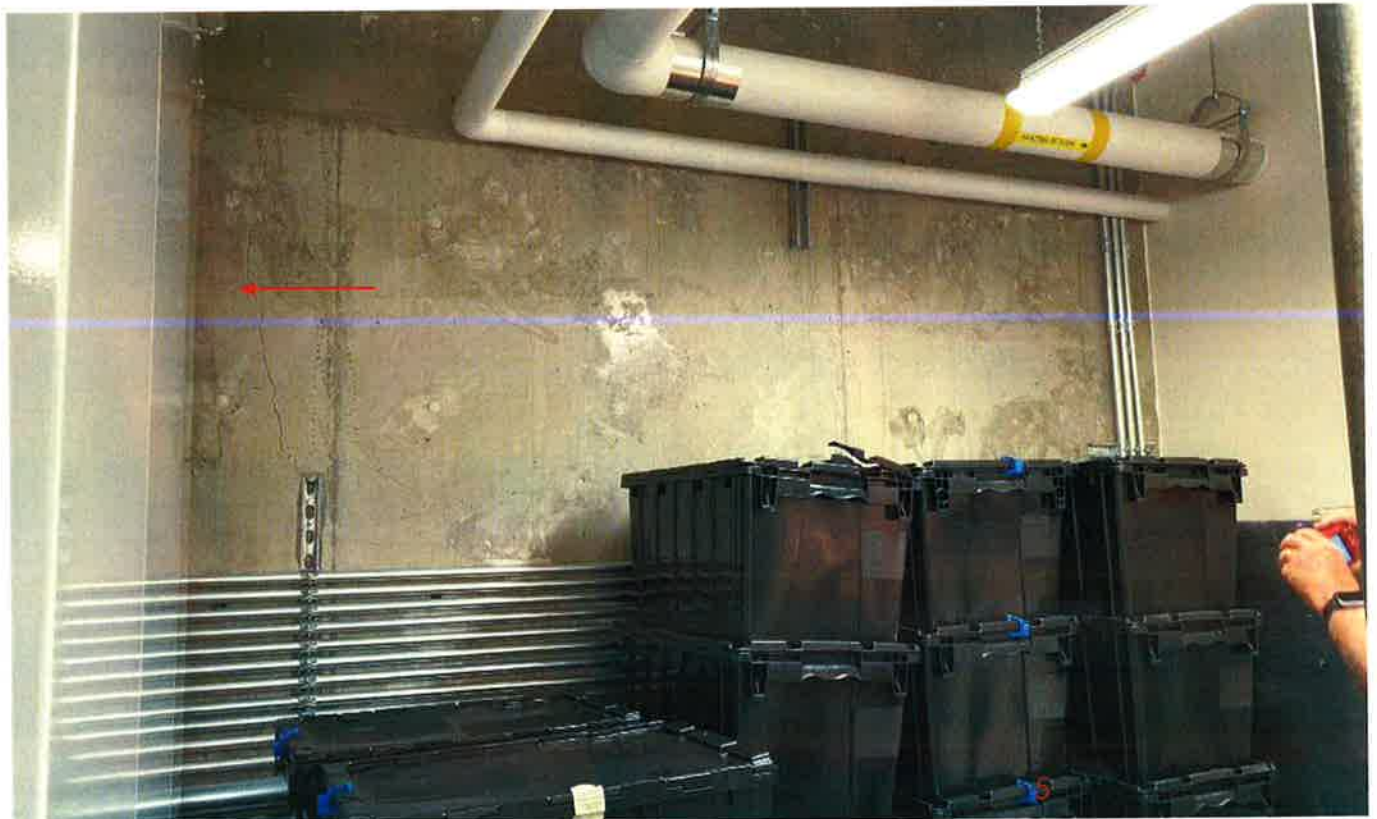
Image 4. At the Activity Rooms on the lower level of the Library, cracking was observed at the corner of door frames on the gypsum board surface and cabinets were pulled away from the walls.

#4. Wall surface cracking at Activity Center

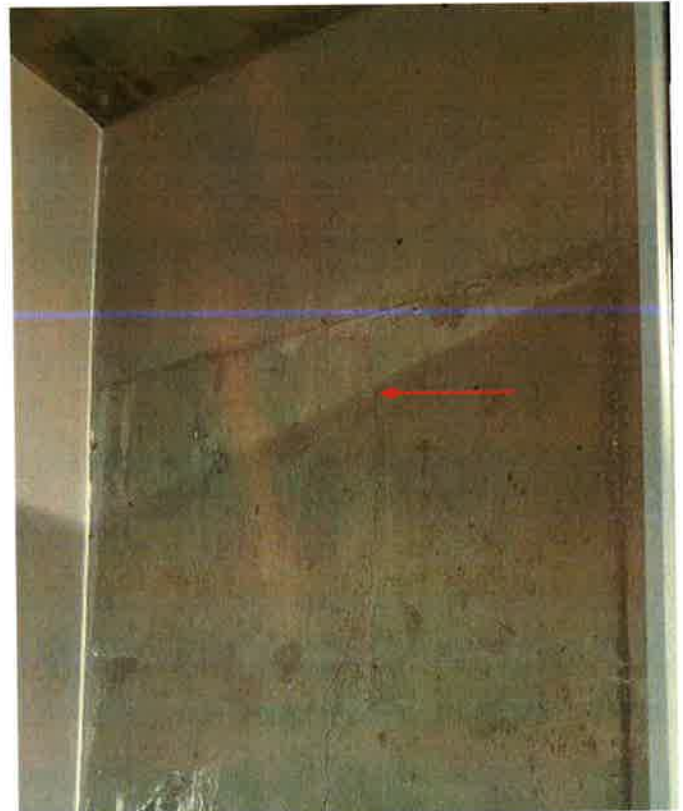
Image 5. On the lower level of the library at the mechanical room, fire riser room, electrical rooms and storage rooms where the building structure is exposed, hairline cracks on the concrete walls were observed.

#5. Concrete wall hairline cracks

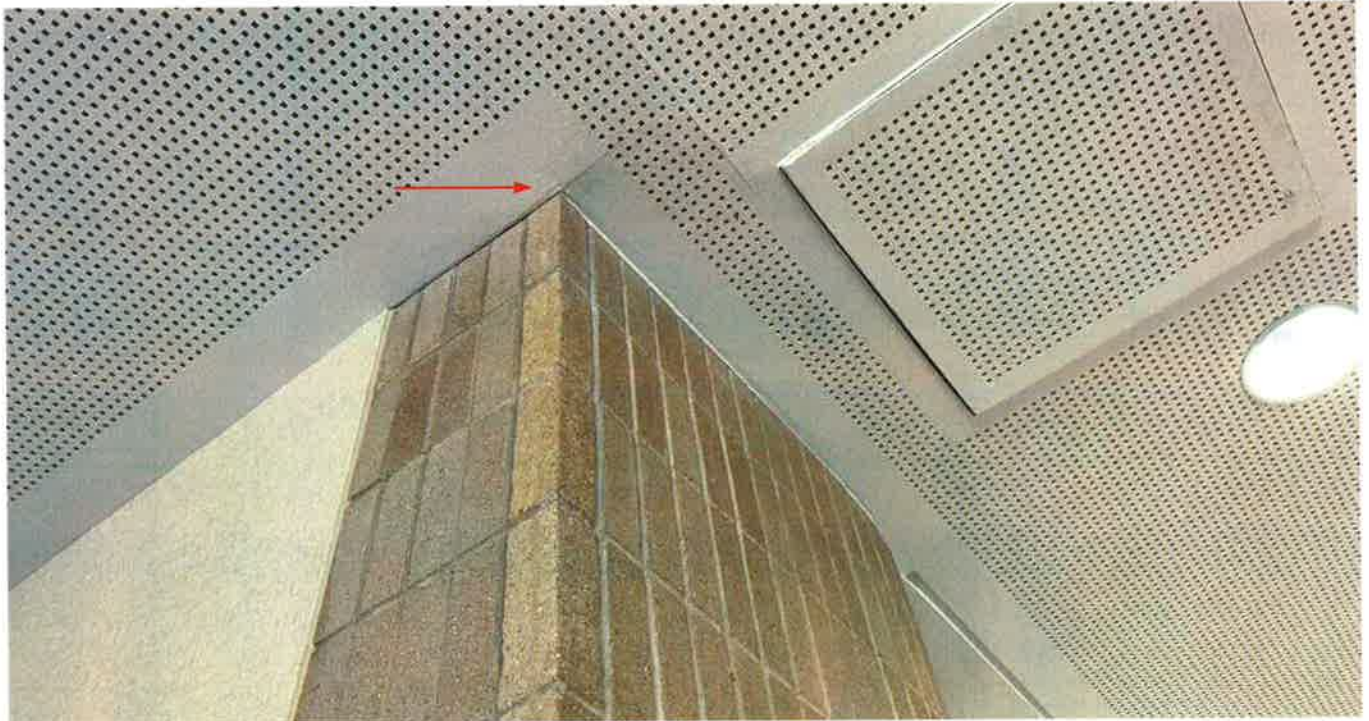
Image 6. At several locations within the building cracking of gypsum board surface was observed at wall corners or wall/ceiling intersections.

#6. Gypsum wall board cracks

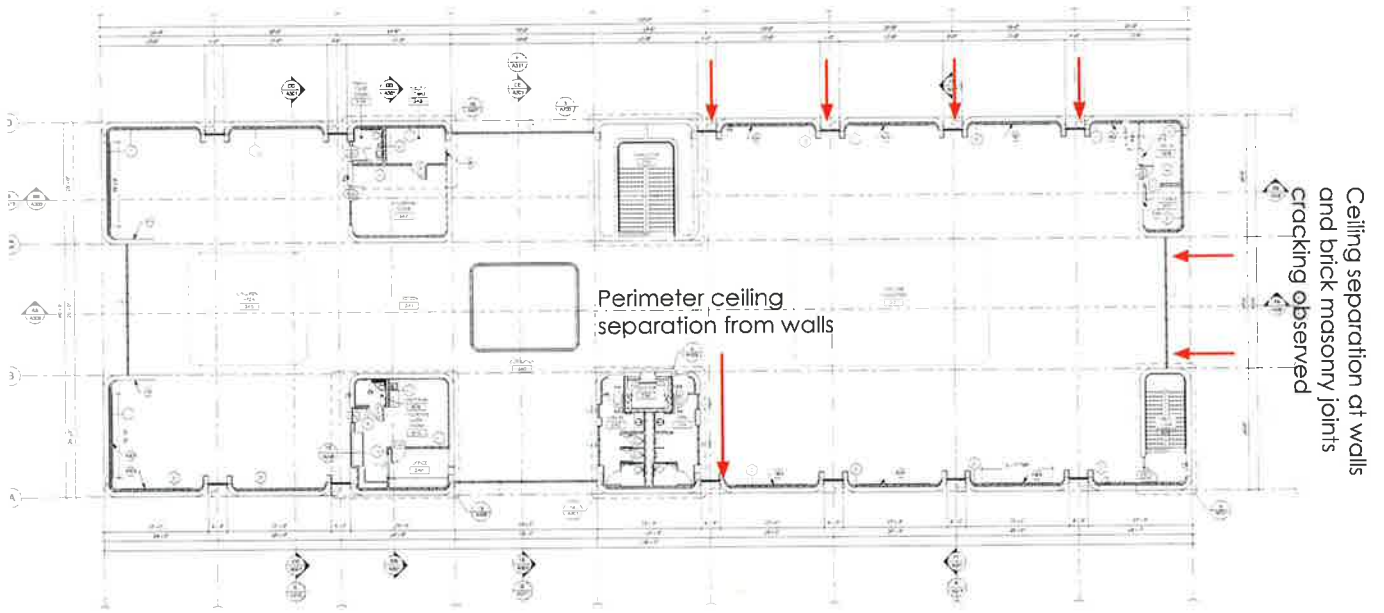
LEVEL 2 FLOOR PLAN

Brick Masonry joints cracks most noticeable in these areas

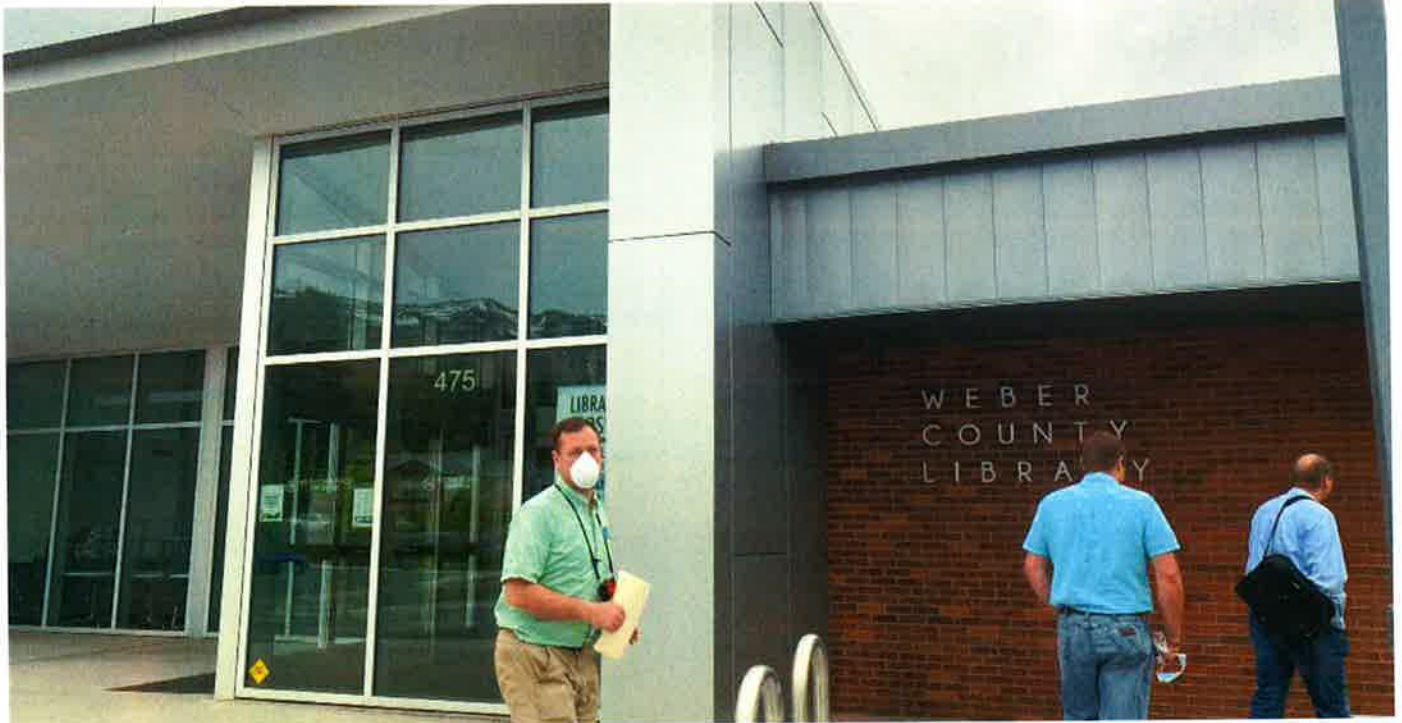
Image 1. The North Entrance appears in good condition and not damage was observed.

#1. North Entrance

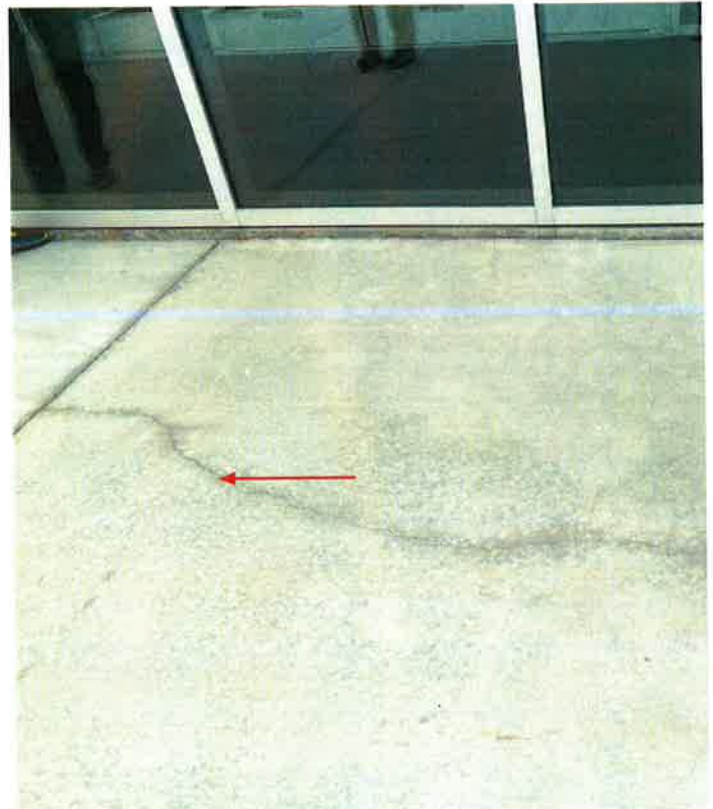
Image 2. The south lower level entrance and patio exhibits fresh hairline cracks to the concrete slab on grade and apparent movement near the glazing.

#2. Lower level South entrance glazing

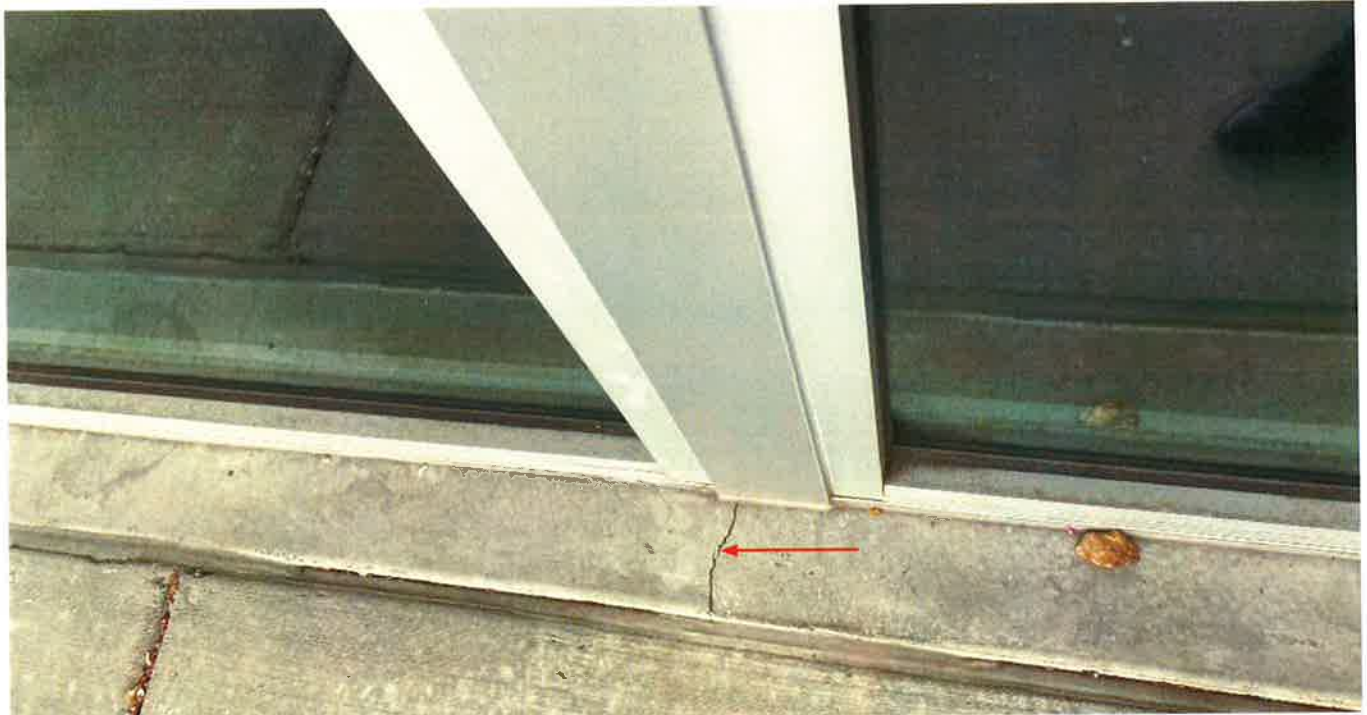
#2. Lower level South entrance concrete slab cracks

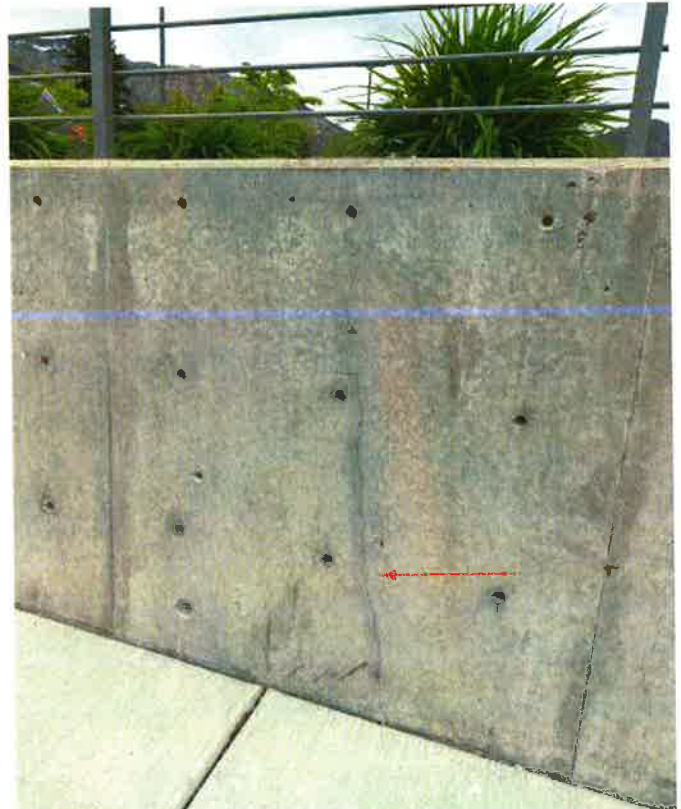
Image 3. The North parking lot, West concrete retaining wall exhibits several cracks along the face of the wall and a large break at the top of the wall, at the connection of one of the railing posts.

#3 Retaining concrete wall cracks

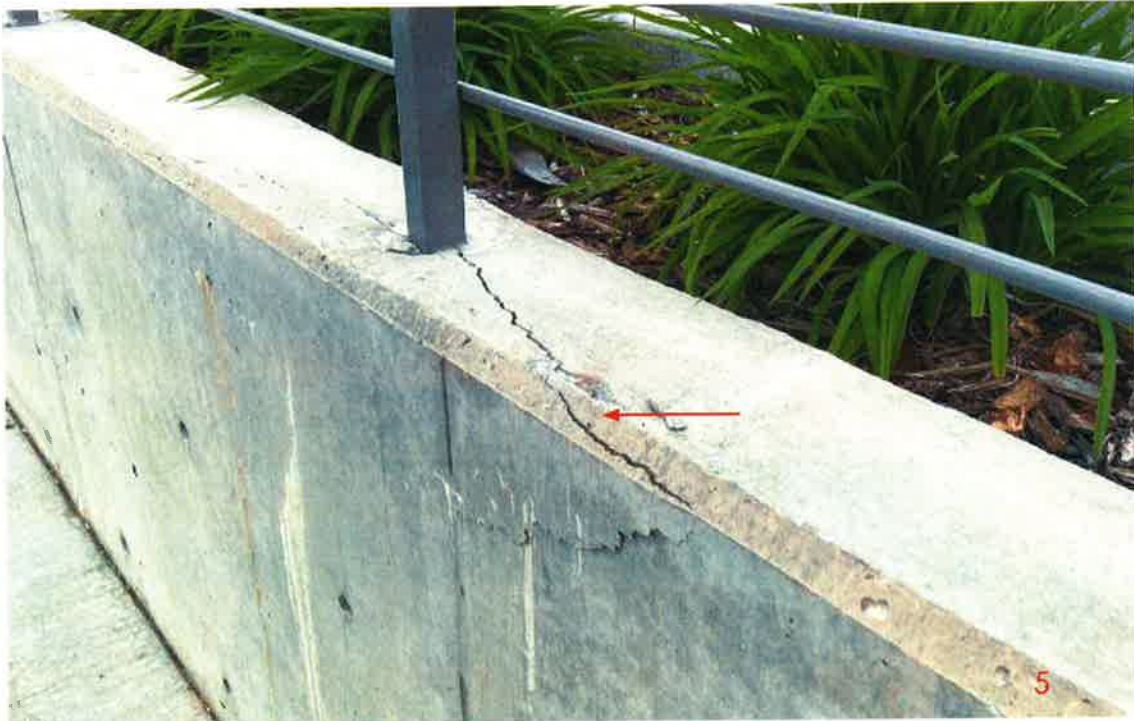
#3 Retaining concrete wall cracks

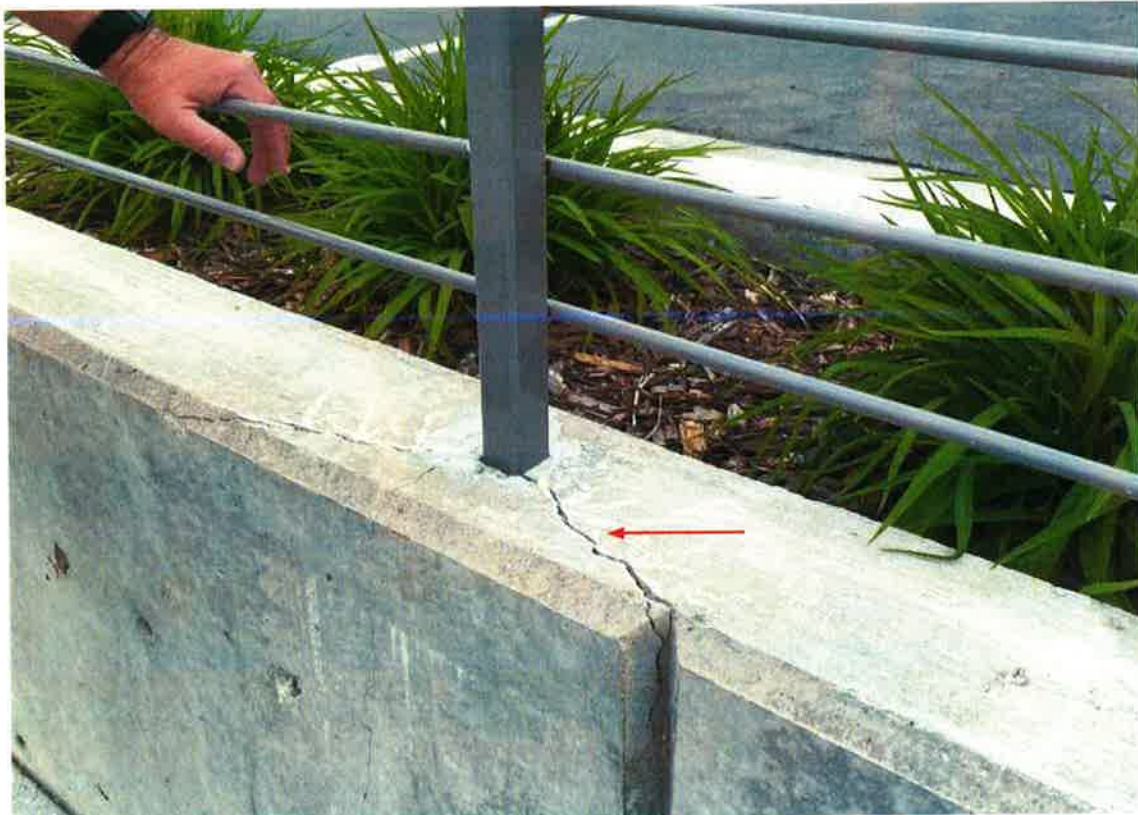
#3 Retaining concrete wall cracks

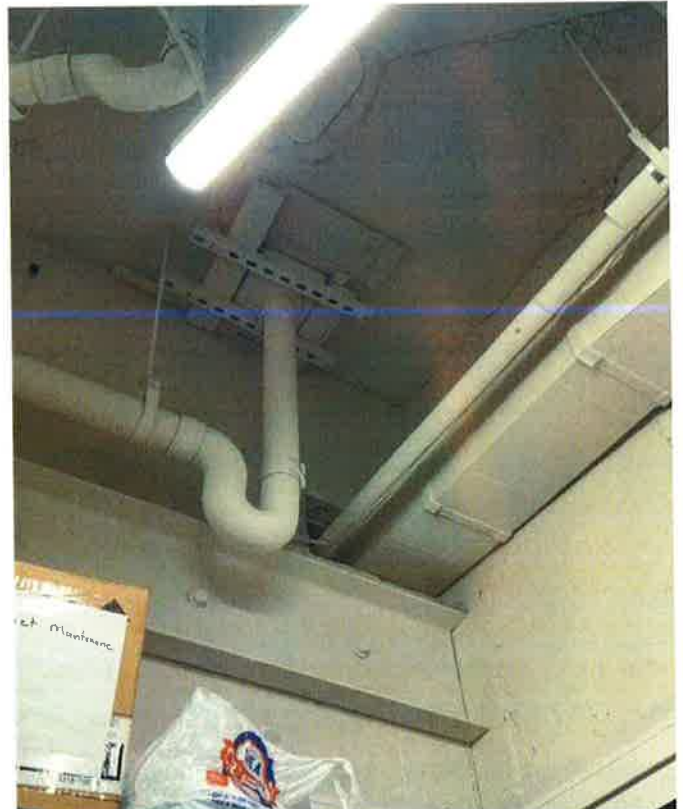
Image 5. The mechanical room, located on the lower level where the building concrete structure is exposed, cracks and signs of movement were observed.

#5. Lower level storage room exhibits cracks at concrete structure

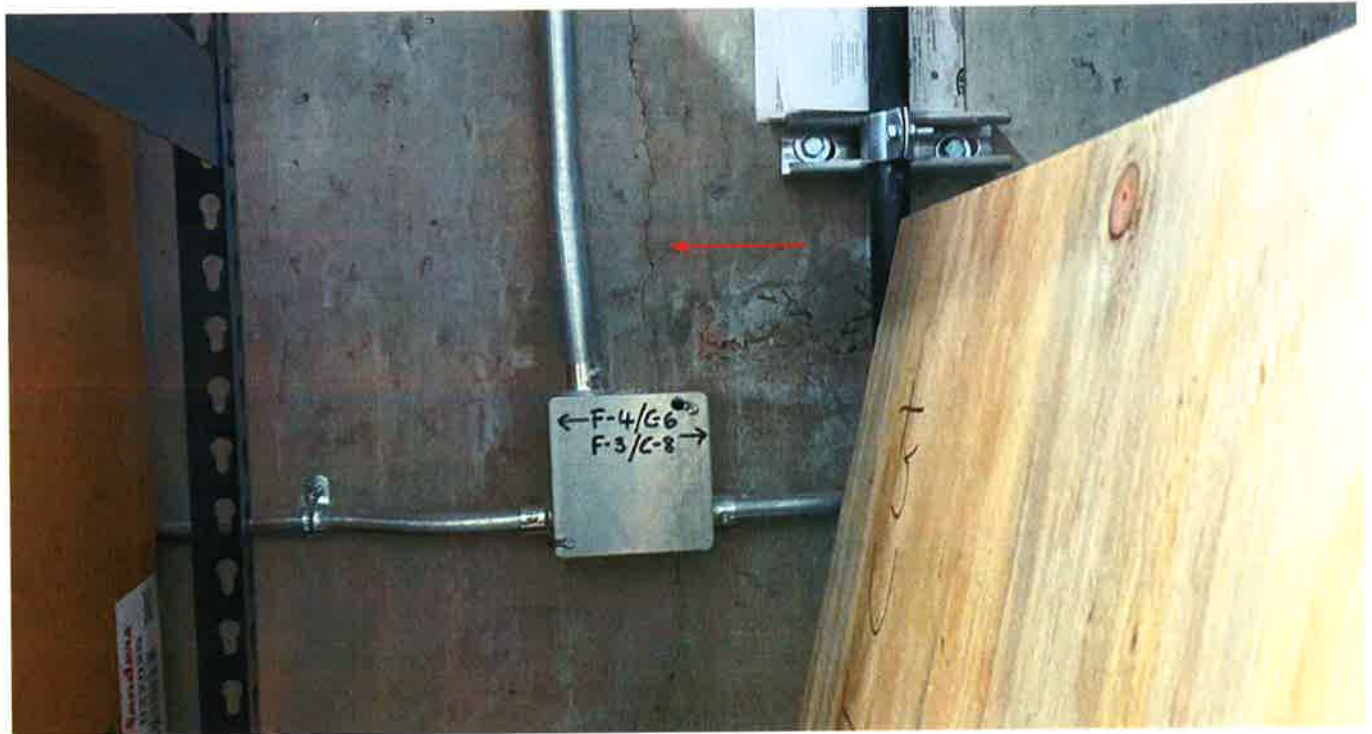
#5. Lower level storage room exhibits cracks at concrete structure

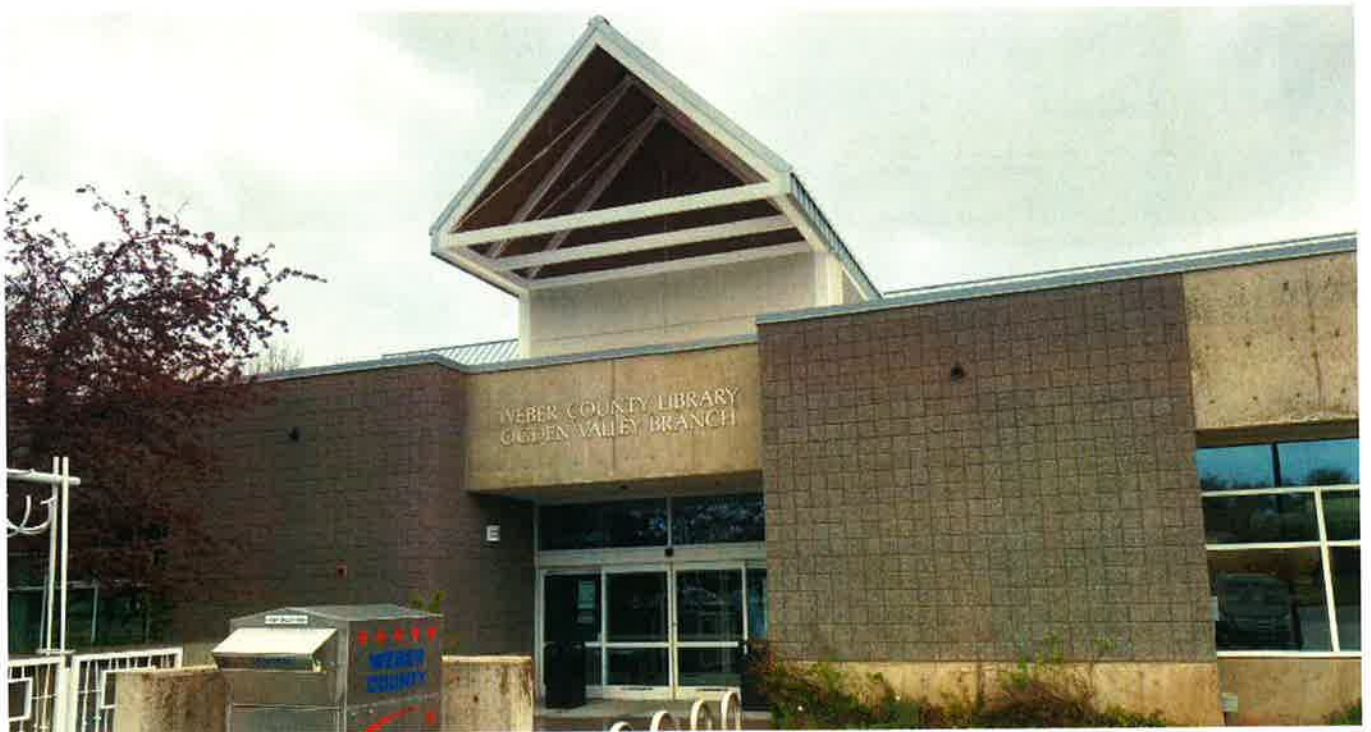
No damage was exhibited at the Main entrance

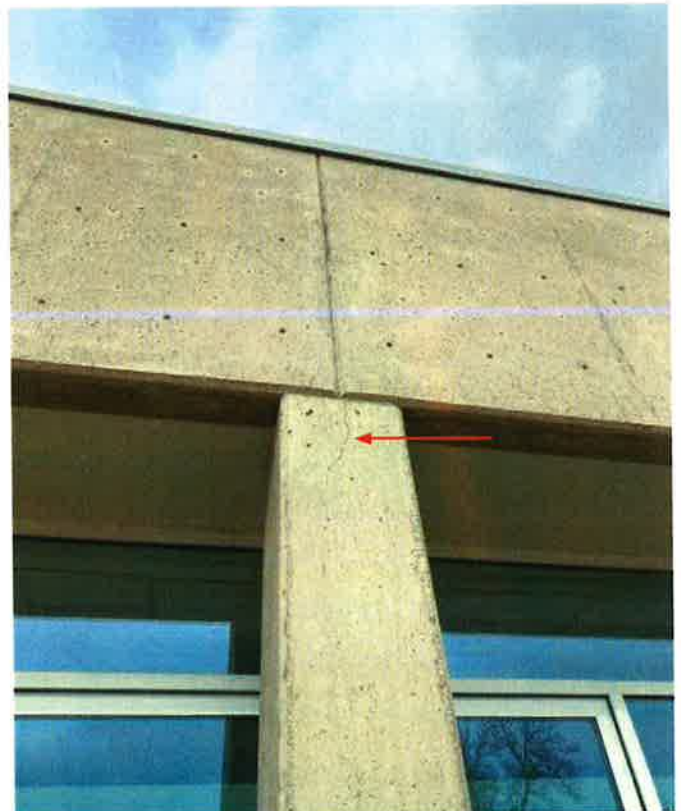
Image 1. Along the West façade, below and above the storefront windows, the exterior concrete walls exhibit hairline cracks. The North, East and South facades also exhibit some cracking of the concrete walls on the lower areas of the walls.

#1. West exterior wall hairline cracks at concrete wall

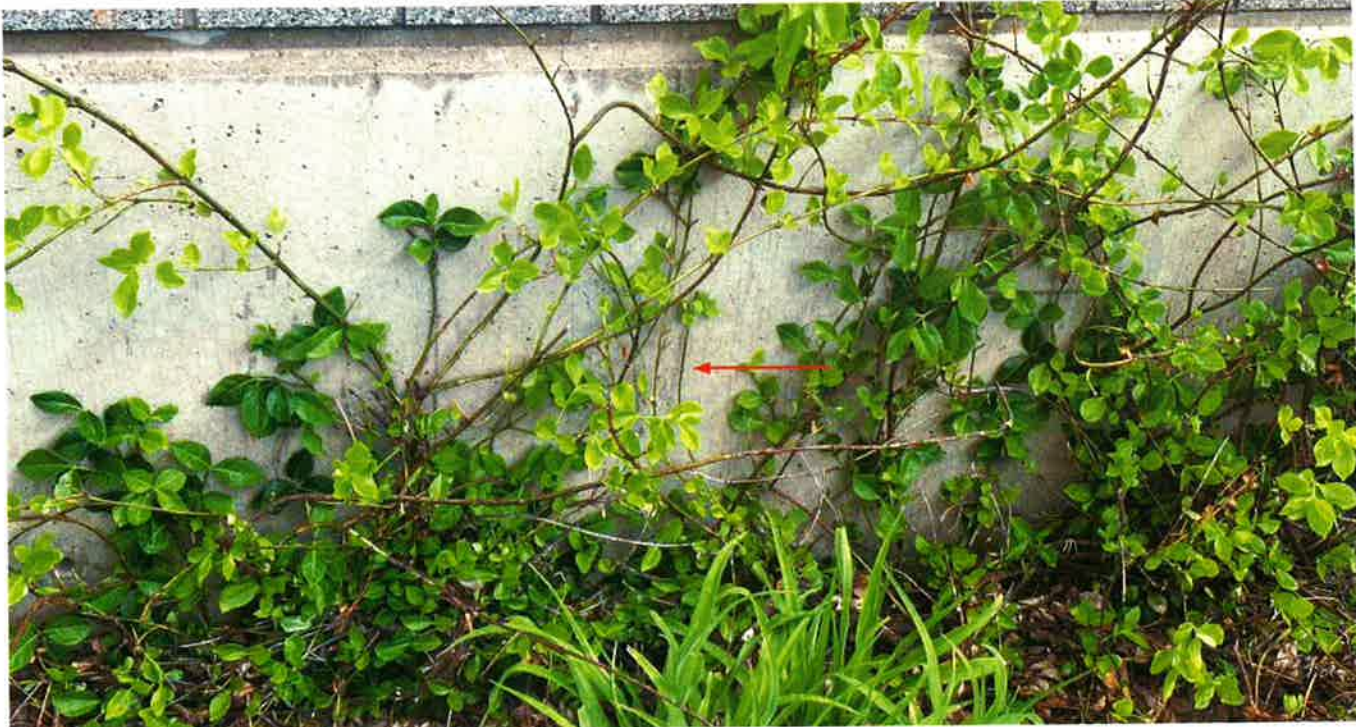
Image 2. The West facade concrete exterior columns and beams exhibits cracks.

#2. West exterior wall hairline cracks at concrete column

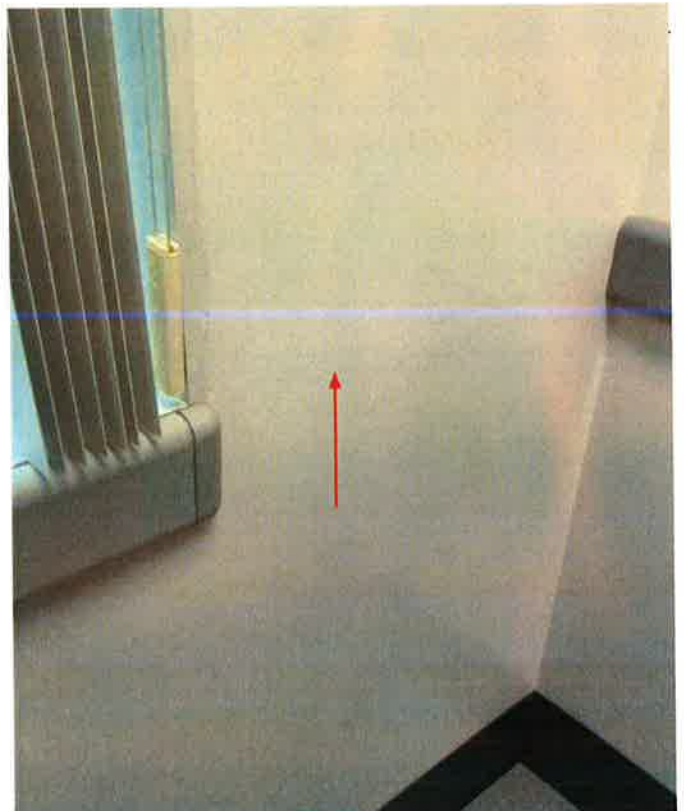
Image 4. At the two (2) offices and break room located along the West exterior wall, cracking of the gypsum board surface was observed at walls below and above the windows.

#4. Hairline cracking of the painted wall at office

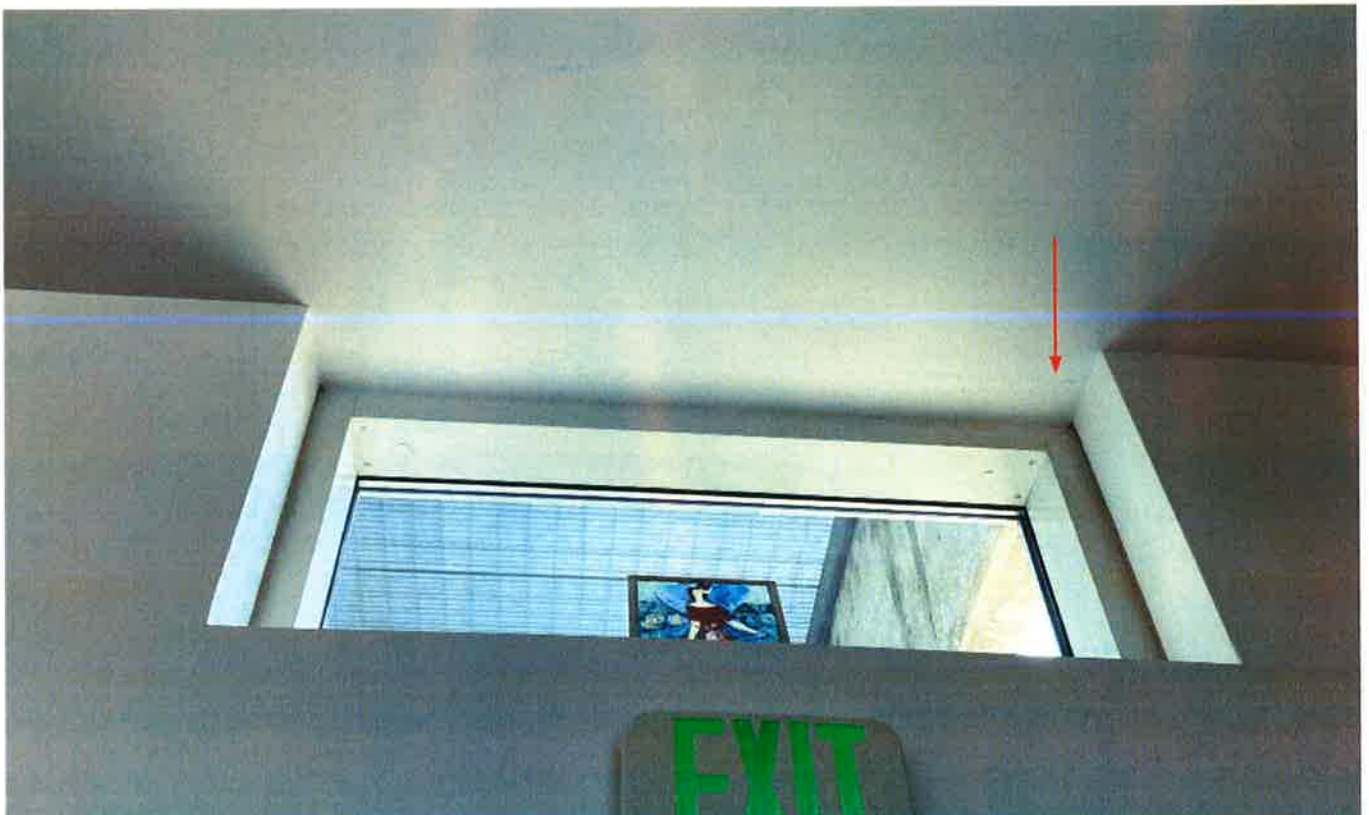
Image 7. At several locations within the building cracking was observed at the corner of alcoves on the painted gypsum board surface.

#7. Hairline crack at painted gypsum wall surface

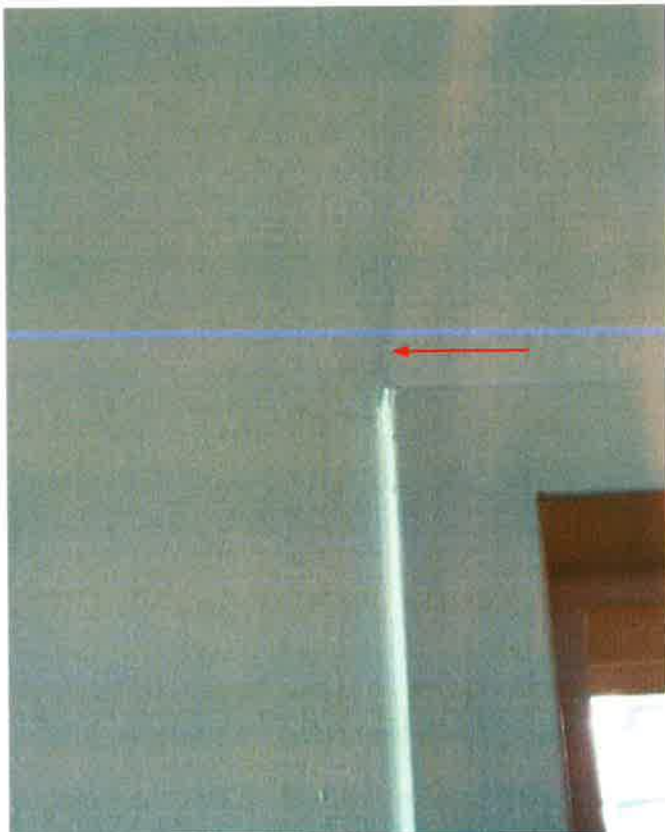
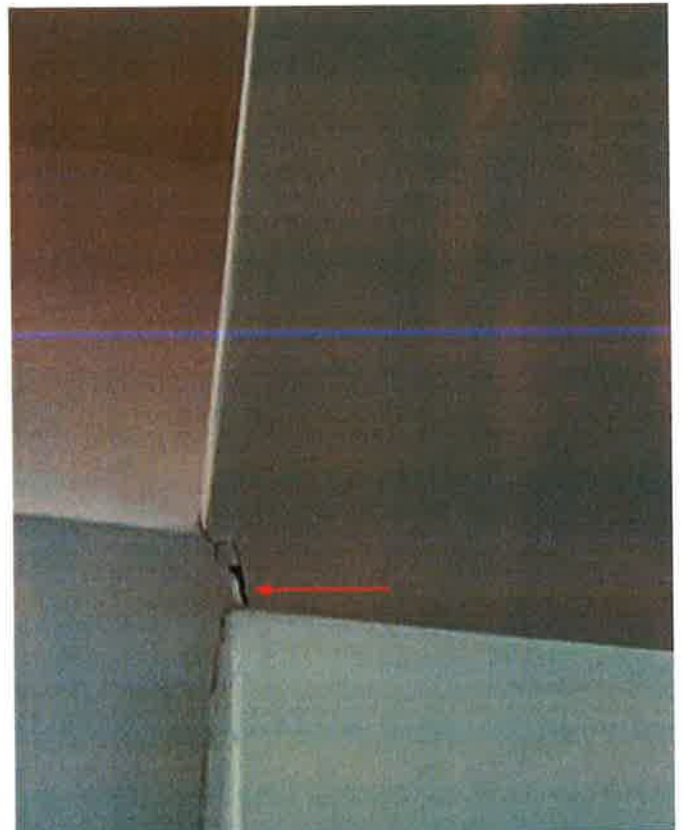
#7. Hairline crack at painted gypsum wall surface

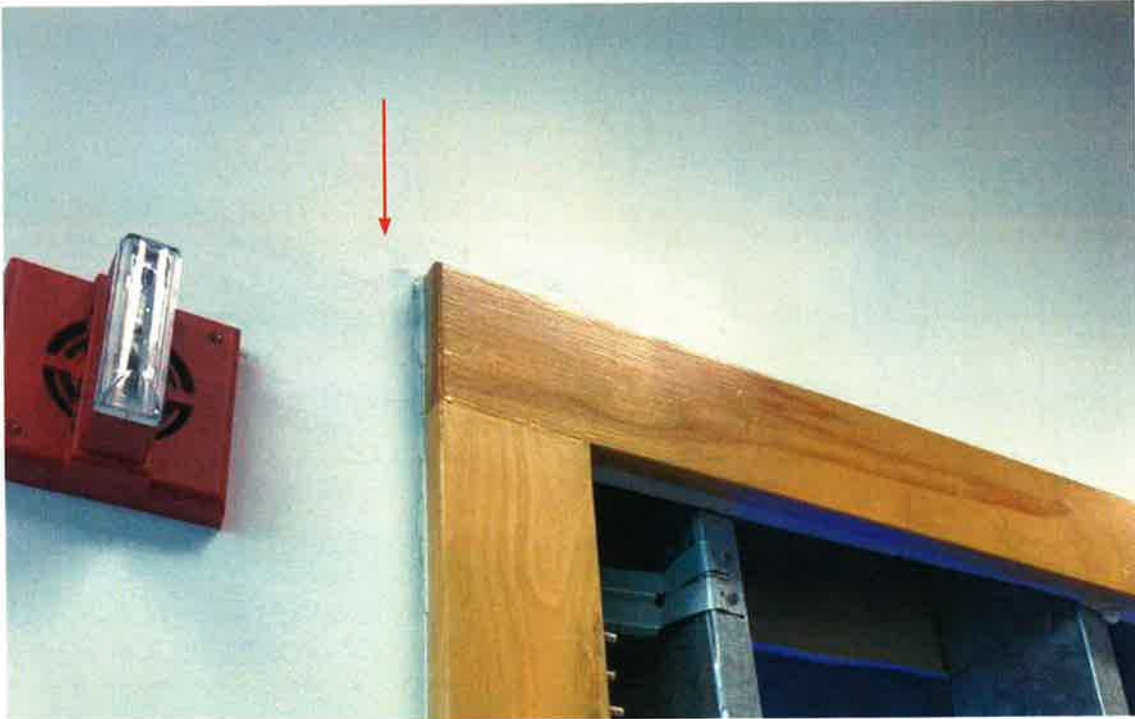
#7. Hairline crack at painted gypsum wall surface
