Preparation of drawings and specifications for mitigation of earthquake damage to five  
County Library buildings:

Weber County Main Library;  
Weber County North Branch;  
Weber County Ogden Valley Branch;  
Weber County Pleasant Valley Branch; and  
Weber County Southwest Branch/Headquarters.

## **EARTHQUAKE DAMAGE ASSESSMENT**

**RE:** Earthquake Damage Observation for the Main Library

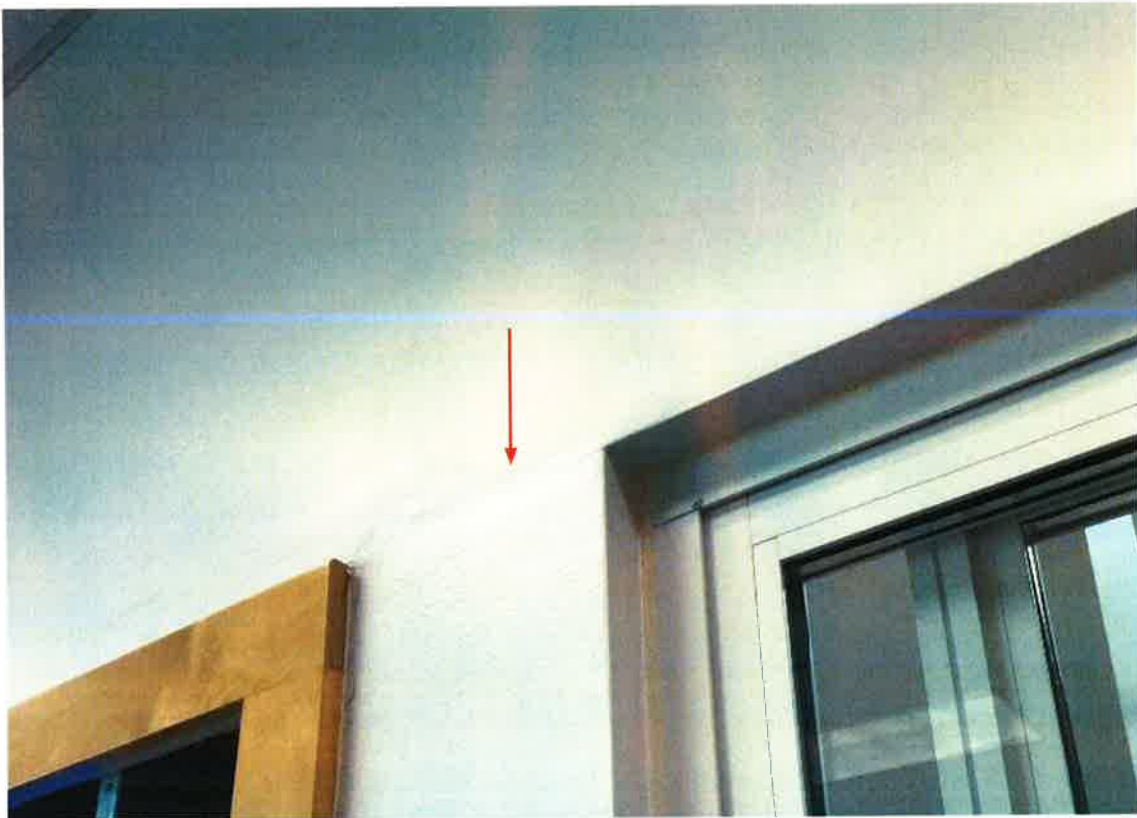
#7. Gypsum board movement observed at millwork corner

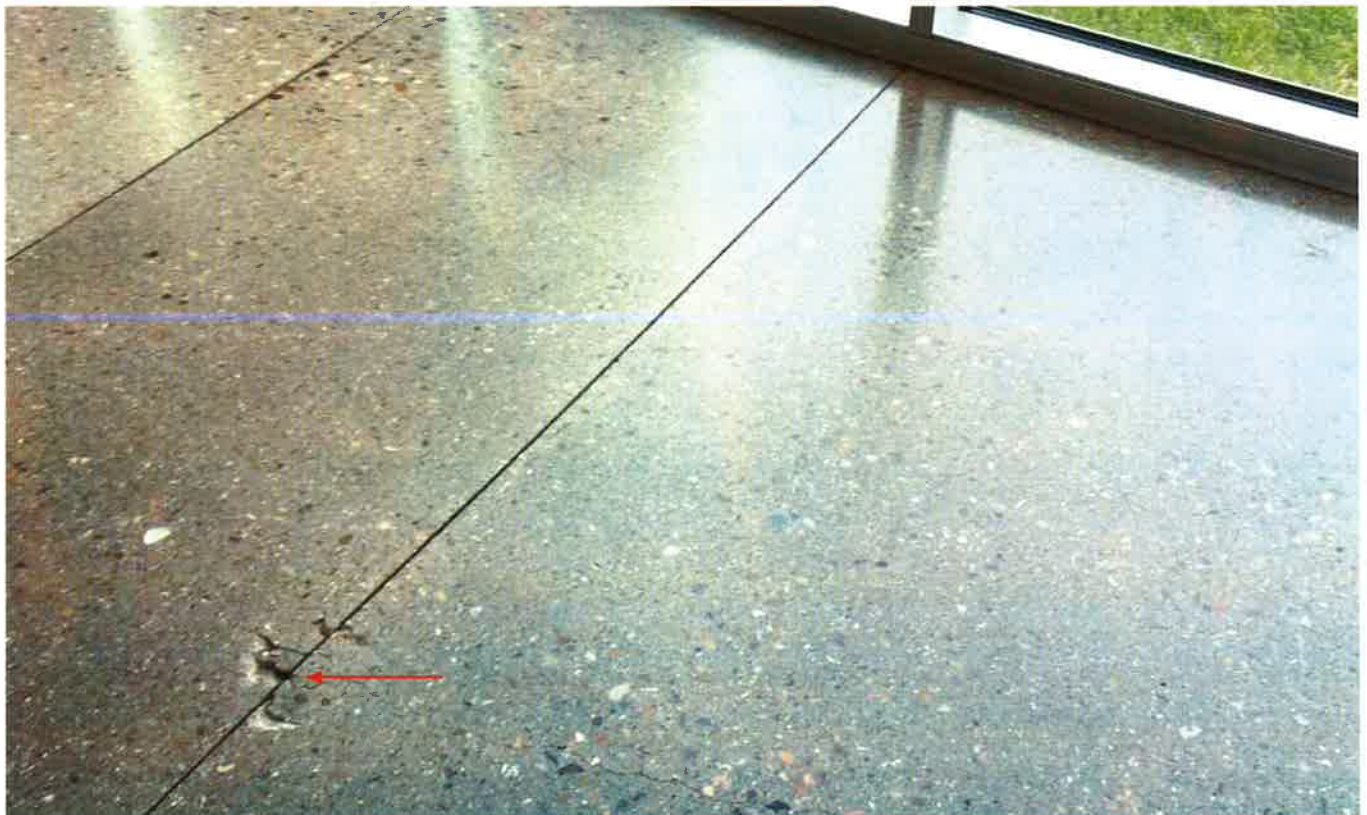
#6. Concrete floor cracks

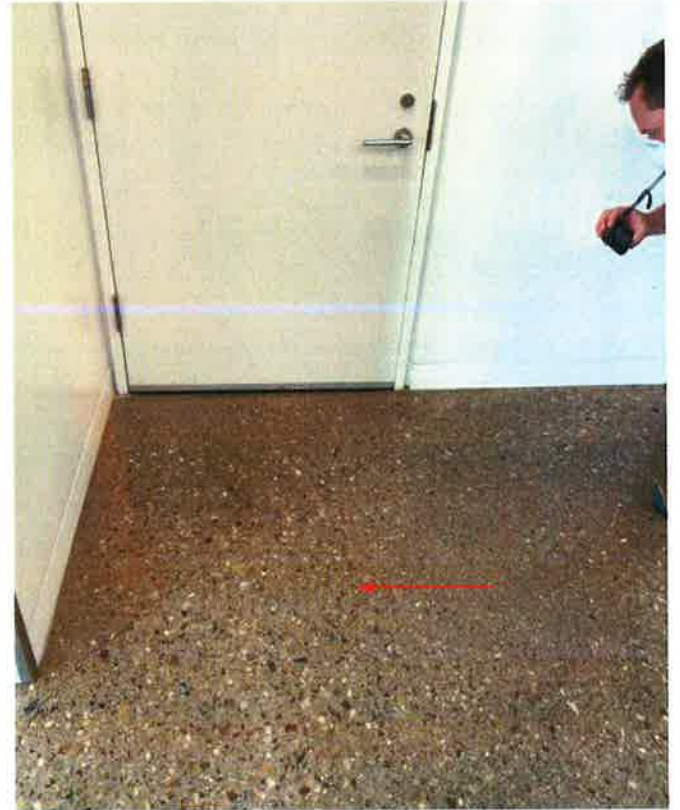
#6. Concrete floor cracks

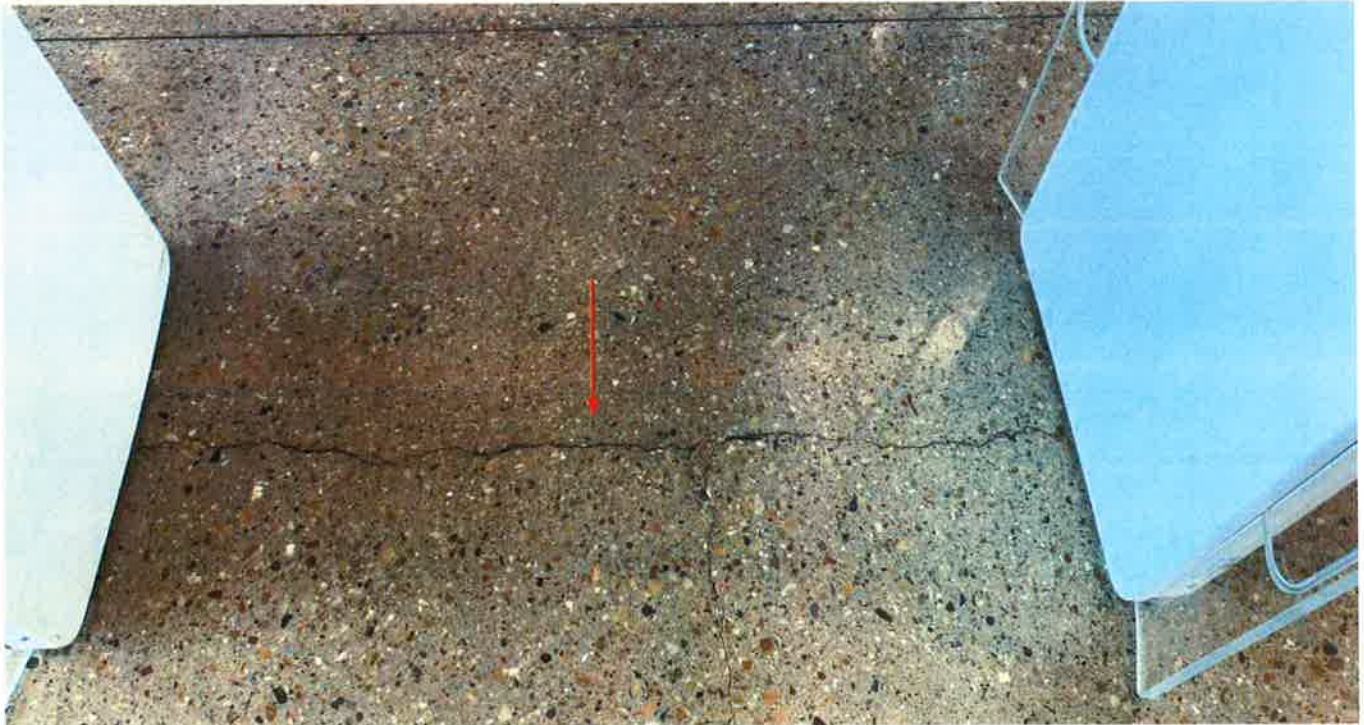
#6. Concrete floor cracks at public circulation areas

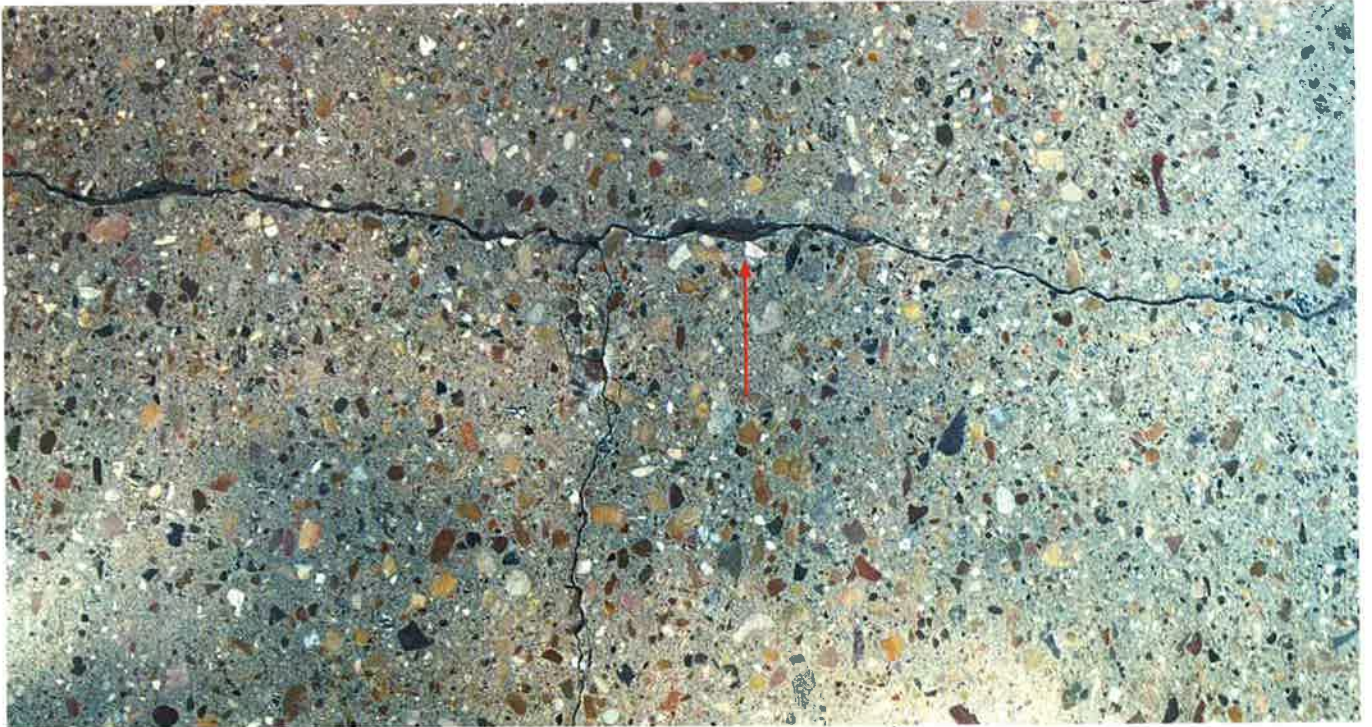
#6. Concrete floor cracks at public circulation areas

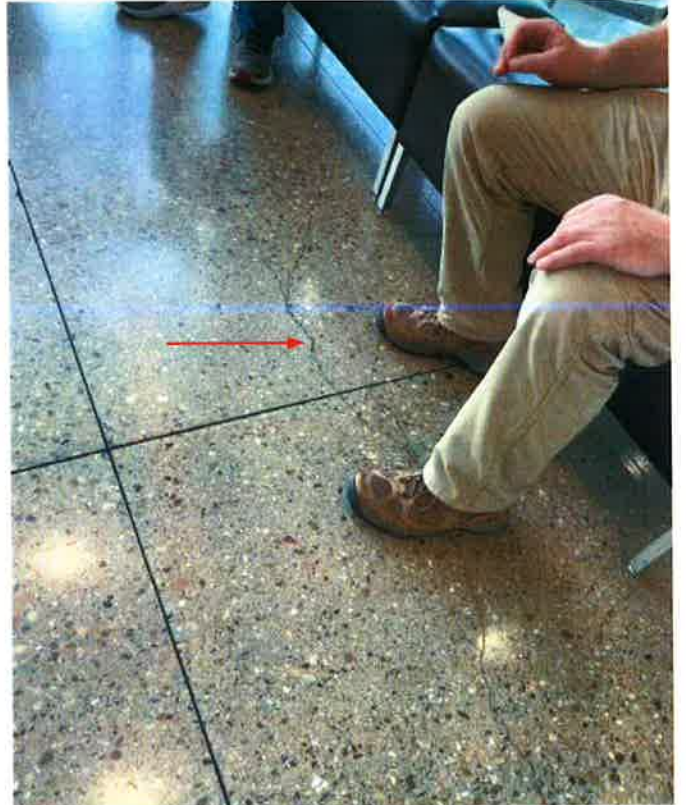
#6. Concrete floor cracks at public circulation areas

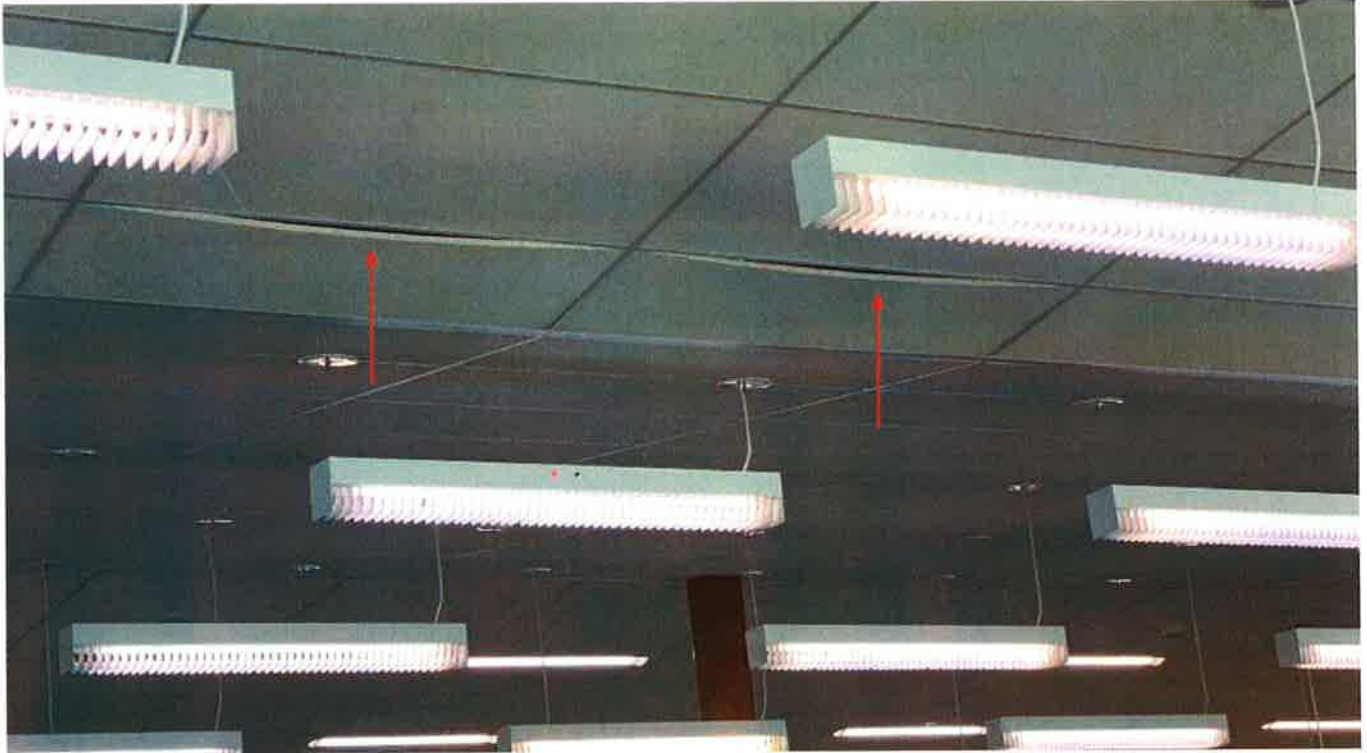
#6. Gypsum board wall cracks

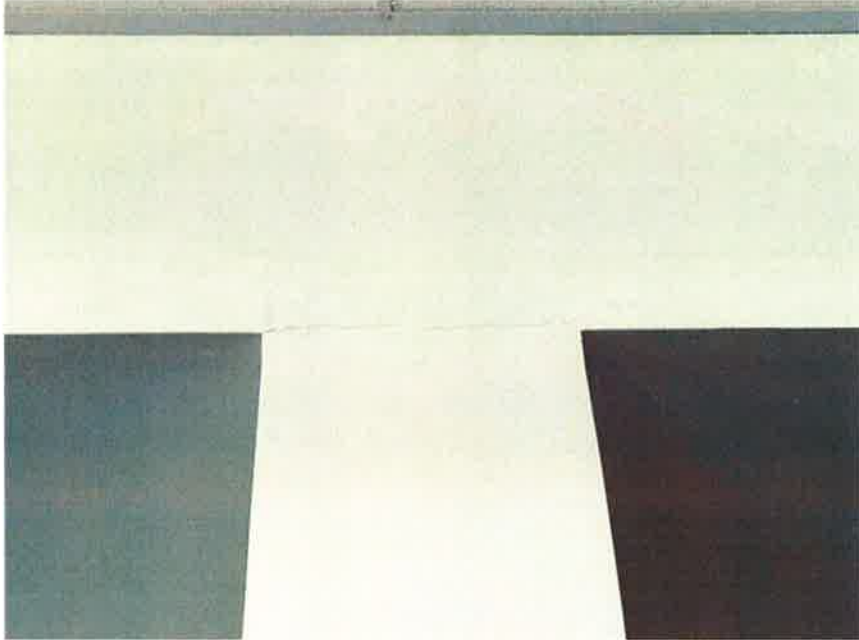
Photo1 – Example of cracks propagating sheetrock walls

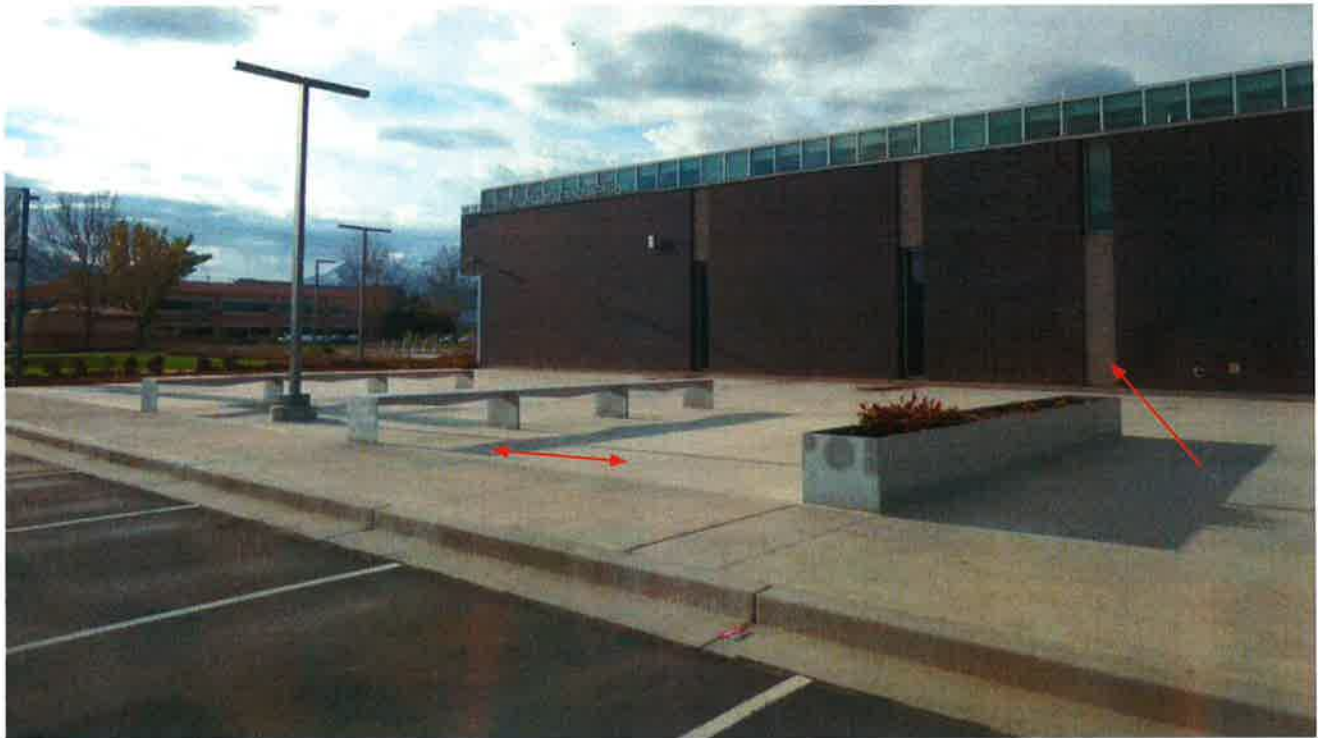
North Facade plaza and typical brick masonry reliefs where damage was observed

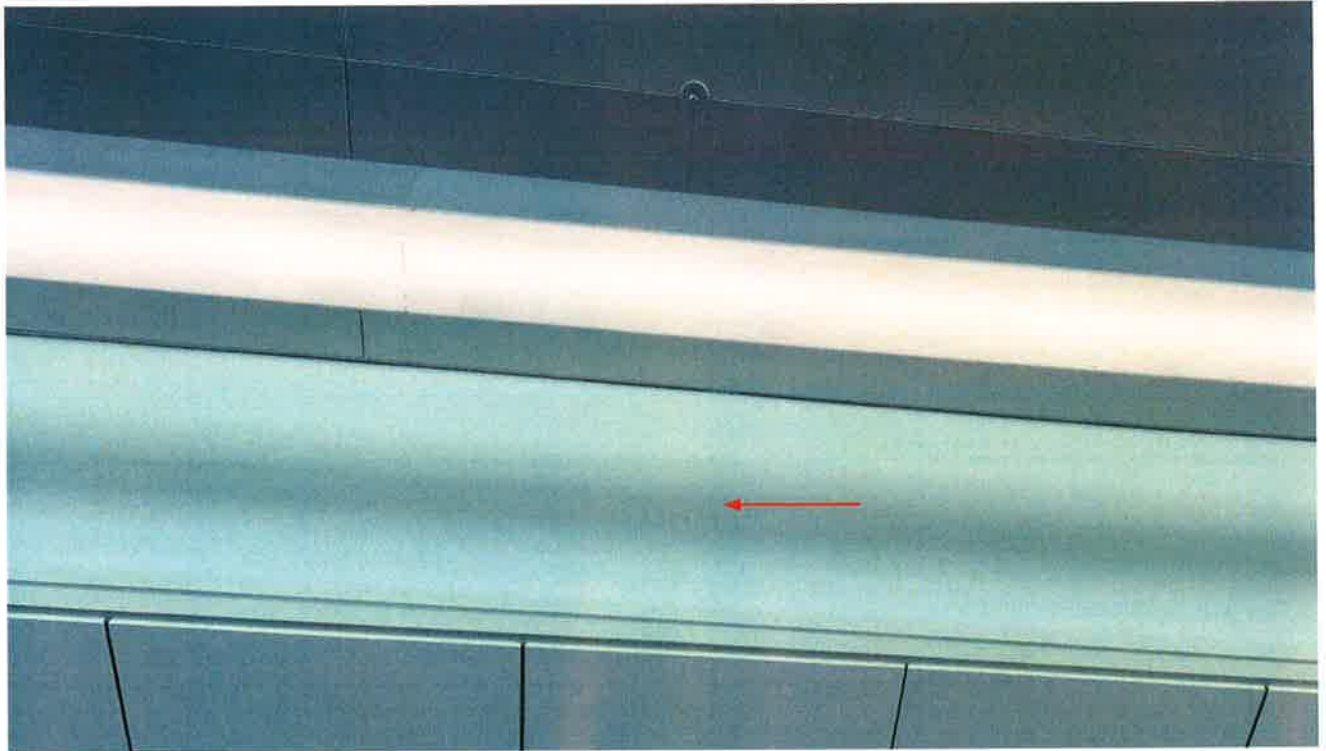
#14. Circulation desk ceiling cracks.

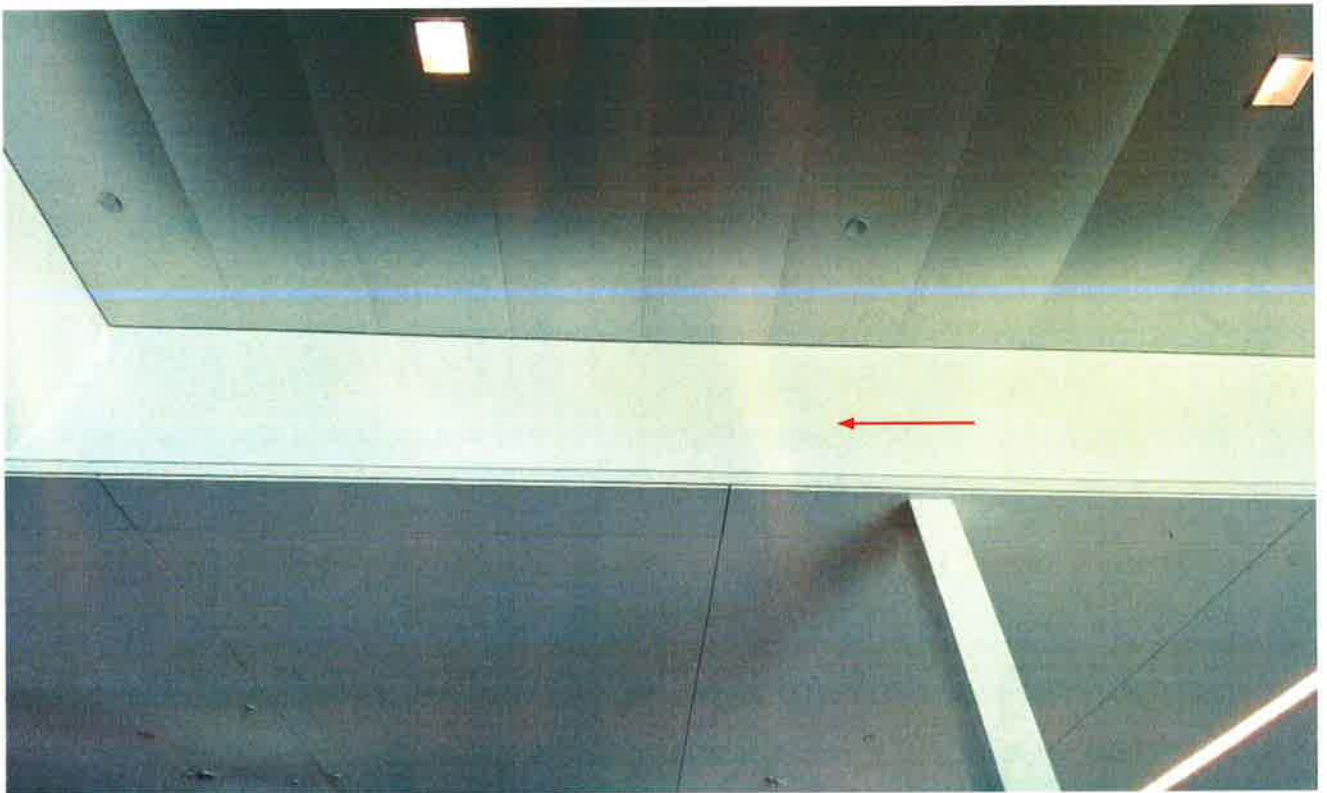
15. Valance walls at Children's Area, Gypsum Board crack

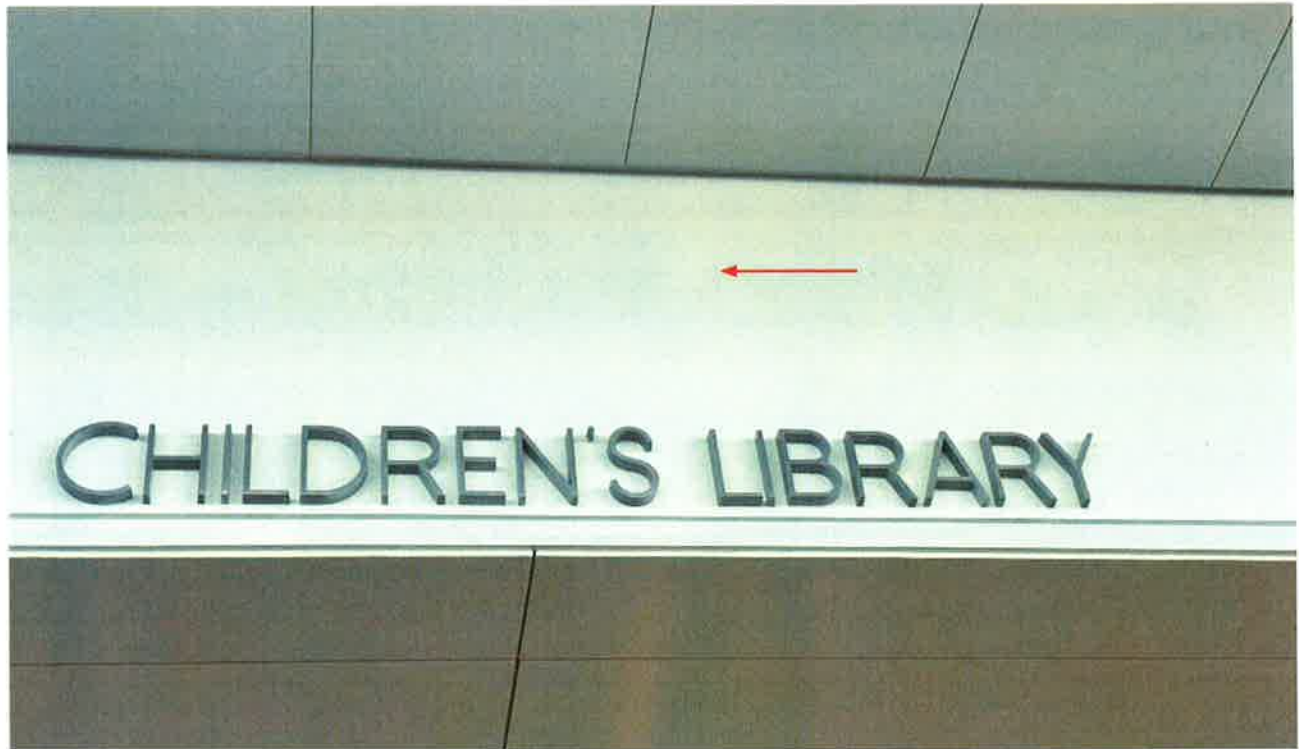
15. Valance walls at Children's Area, Gypsum Board crack

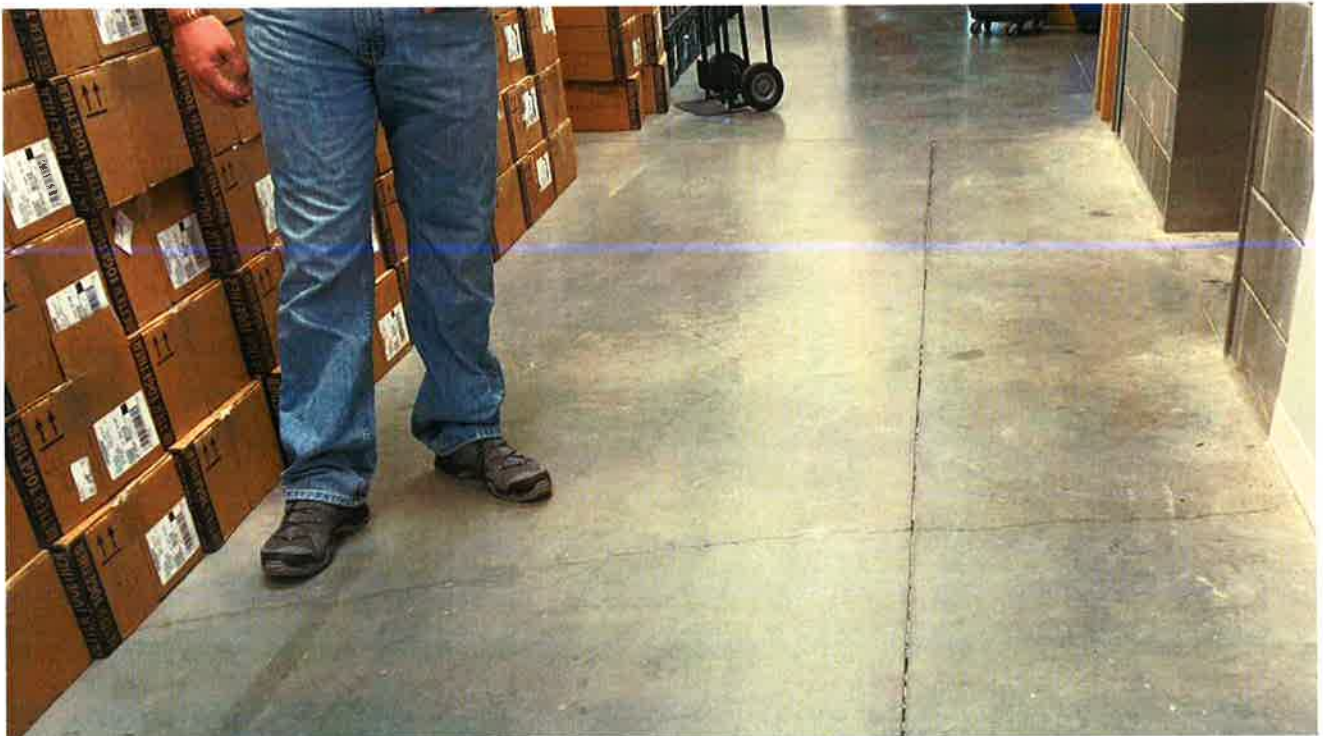
#18. Maintenance Area SR Hall cracks at concrete floor,

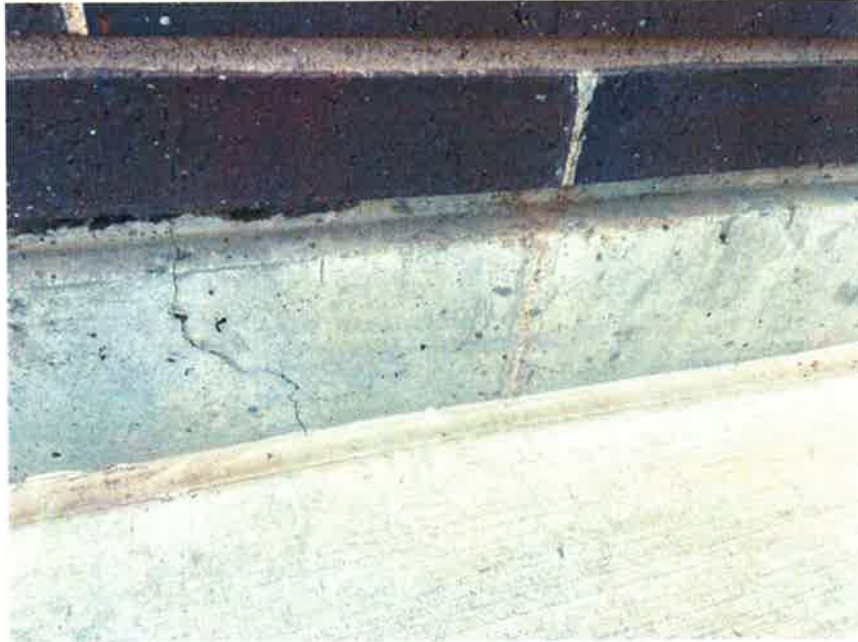
Photo 2 – Example of cracks propagating in masonry veneer

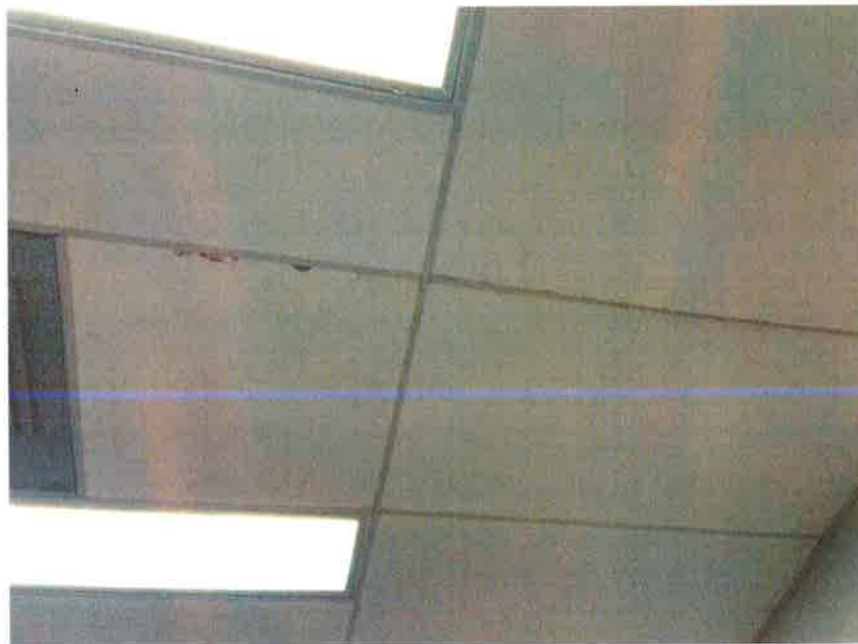
Photo #5 – Exterior soffits appear to have shifted
