Preparation of drawings and specifications for mitigation of earthquake damage to five  
County Library buildings:

Weber County Main Library;  
Weber County North Branch;  
Weber County Ogden Valley Branch;  
Weber County Pleasant Valley Branch; and  
Weber County Southwest Branch/Headquarters.

## **EARTHQUAKE DAMAGE ASSESSMENT**

**RE:** Earthquake Damage Observation for the Main Library

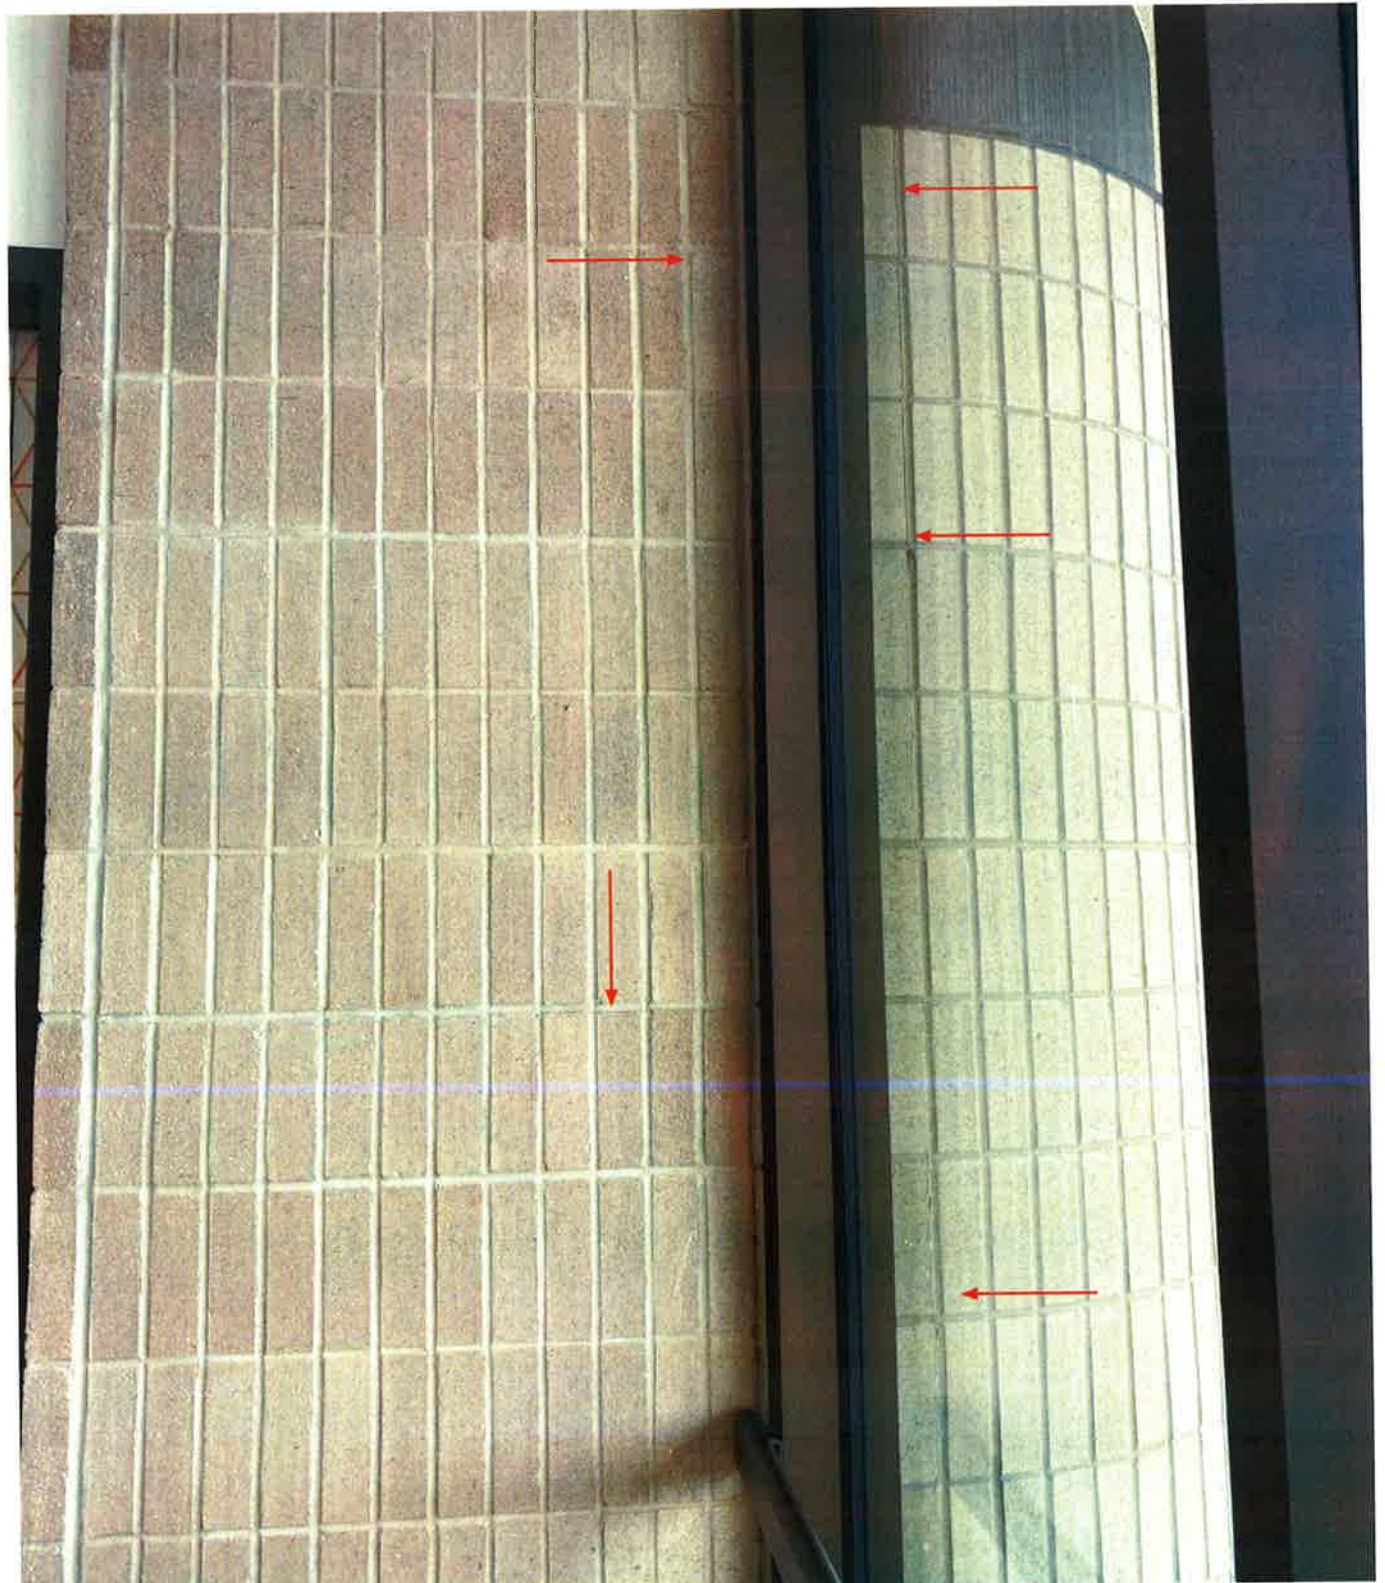
Image 2. On level 2, at several locations along the exterior walls, the exterior brick masonry exhibits cracks along the mortar joints on several areas. This is visible though the glass on the exterior face of the building but also as the brick masonry returns into the building. We photographed many of these instances, but there may be areas out of view that need to be accessed with a lift for better visibility. These cracks could carry moisture from the outside of the building into the wall assembly if left un-addressed.

#2. Brick masonry joint cracking

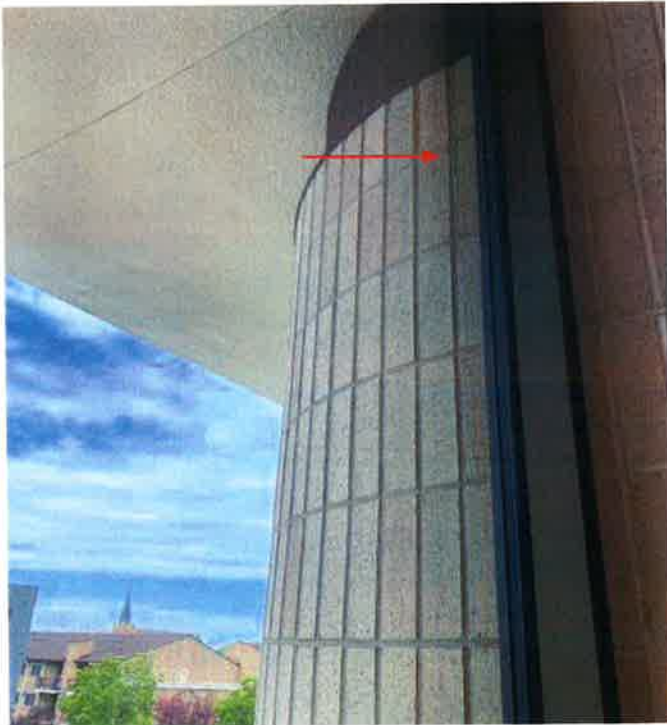
#2. Brick masonry joint cracking on level 2

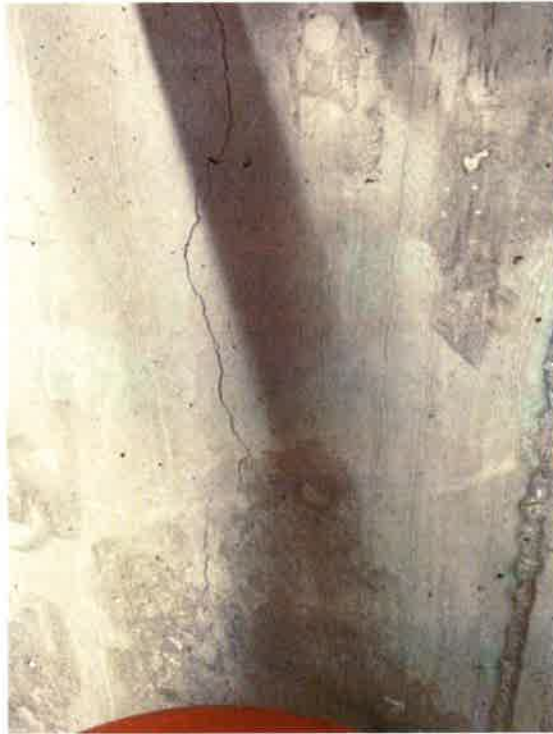
Photo1 – Example of cracks in foundation walls

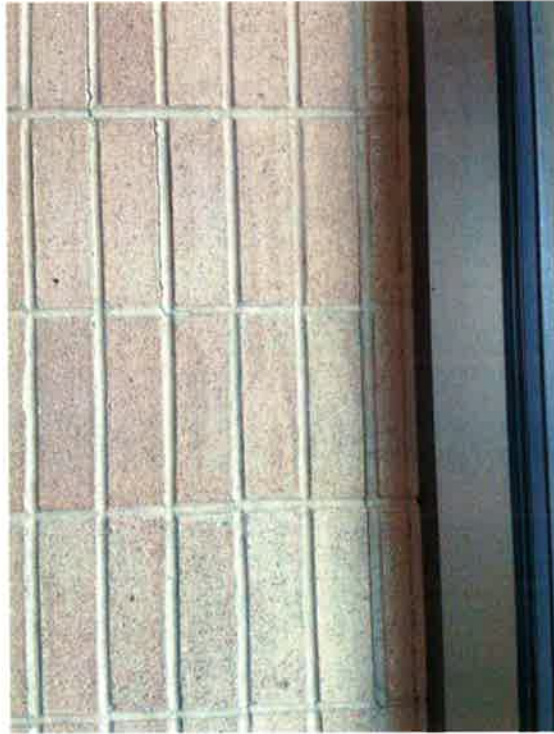
Photo #3 – Example of cracks brick veneer

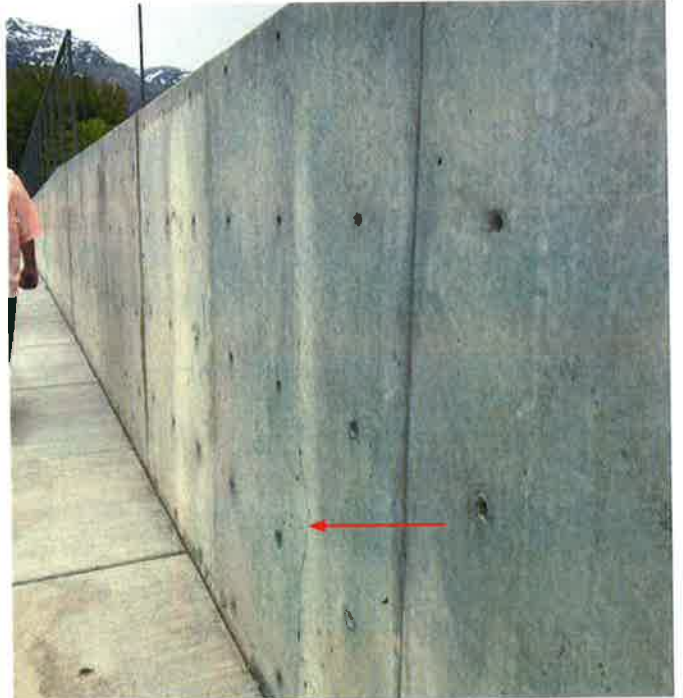
Image 3. The North parking lot, West concrete retaining wall exhibits several cracks along the face of the wall and a large break at the top of the wall, at the connection of one of the railing posts.

#3 Retaining concrete wall cracks

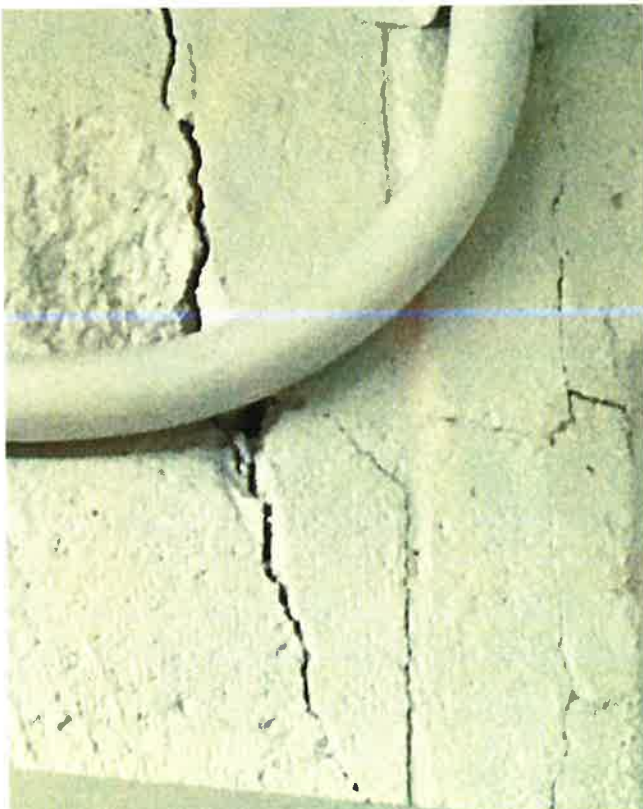
Image 5. The mechanical room, located on the lower level where the building concrete structure is exposed, cracks and signs of movement were observed.

#5. Lower level storage room exhibits cracks at concrete structure

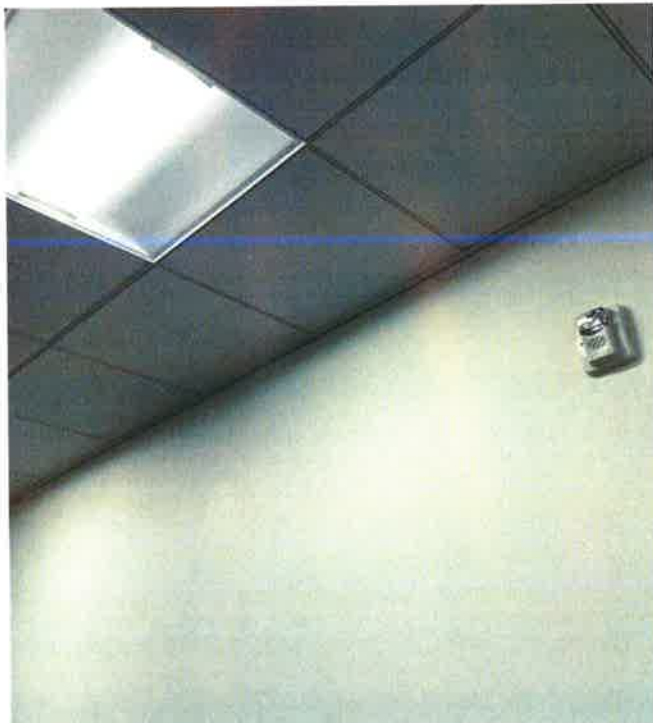
Image 6. Minor movement of ceiling tiles was observed on the stack's area. Some light fixtures lenses need to be re-seated.

#6. Ceiling tile displacement

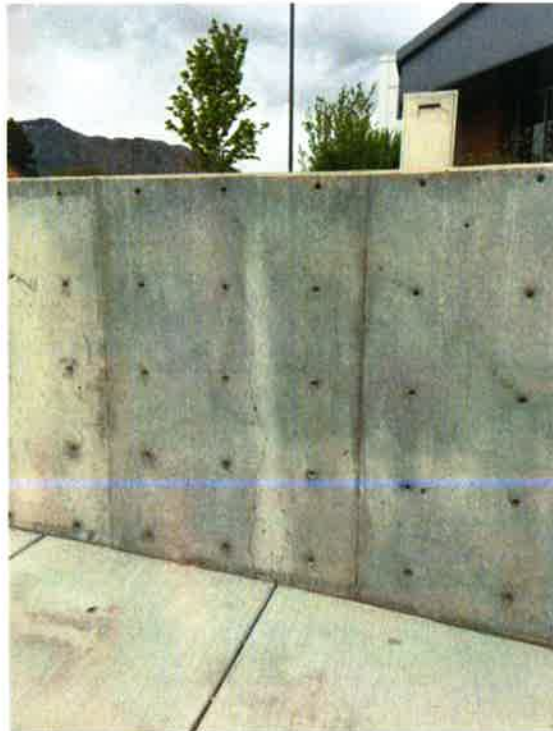
Photo #4 – Example of cracks in retaining wall

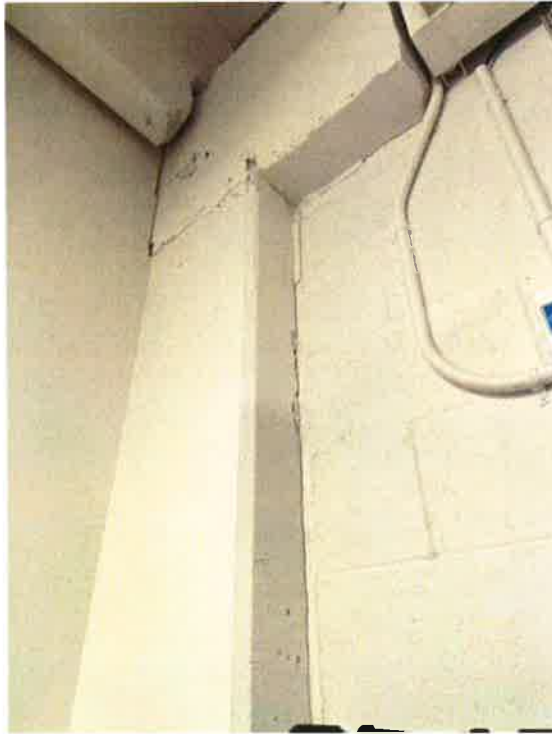
Photo #5 – Example of cracks in masonry and concrete walls

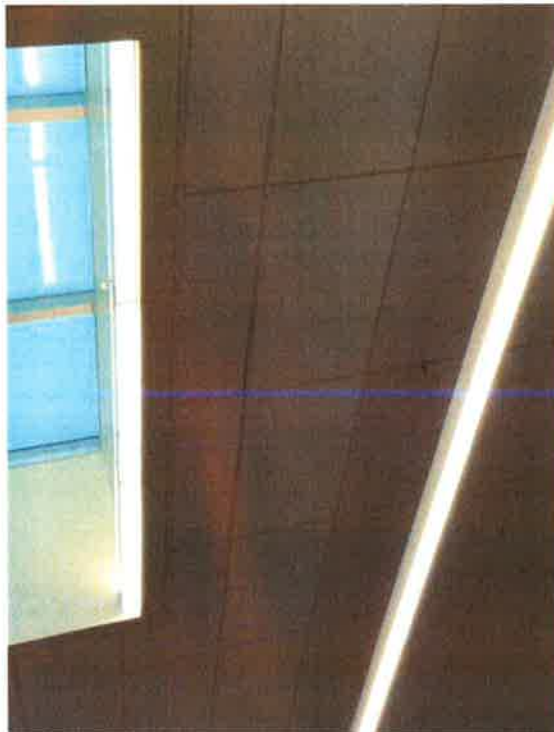
Photo #6 – Example of displaced ceiling tile

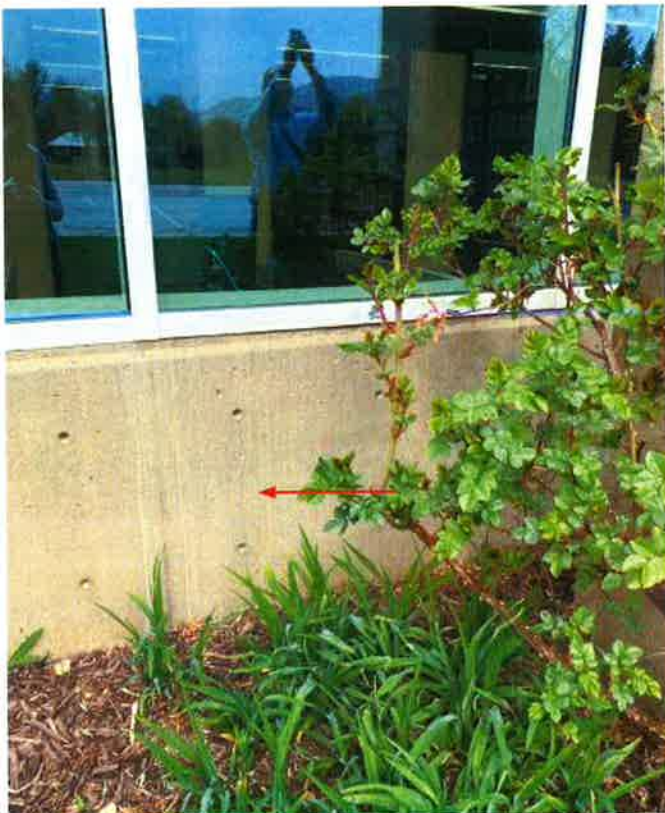
Image 1. Along the West façade, below and above the storefront windows, the exterior concrete walls exhibit hairline cracks. The North, East and South facades also exhibit some cracking of the concrete walls on the lower areas of the walls.

#1. West exterior wall hairline cracks at concrete wall

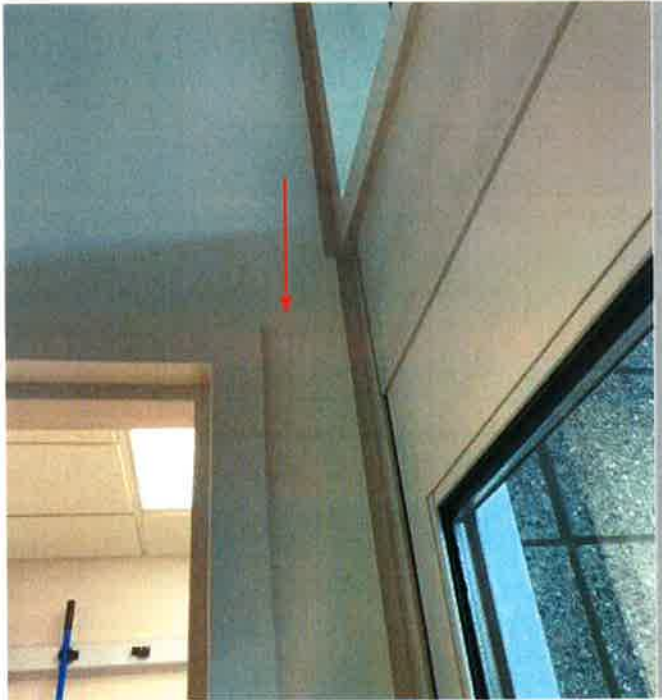
#3. Gypsum board wall cracks at door frames

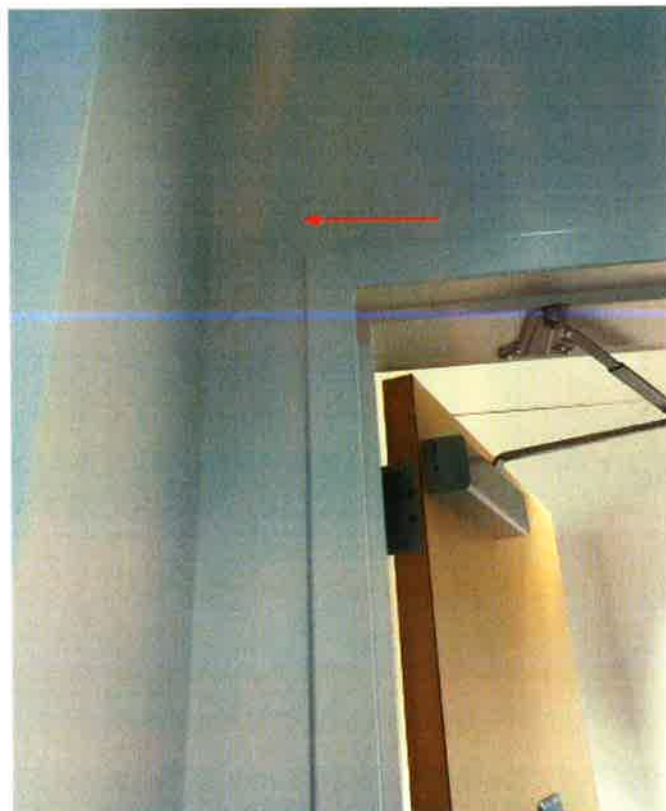
#3. Gypsum board wall cracks at door frames

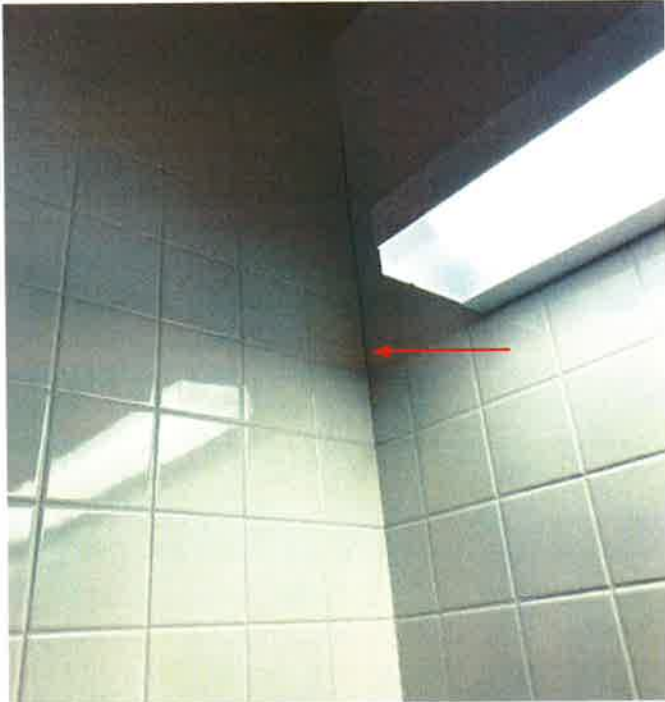
#3. Hairline cracking near door frames

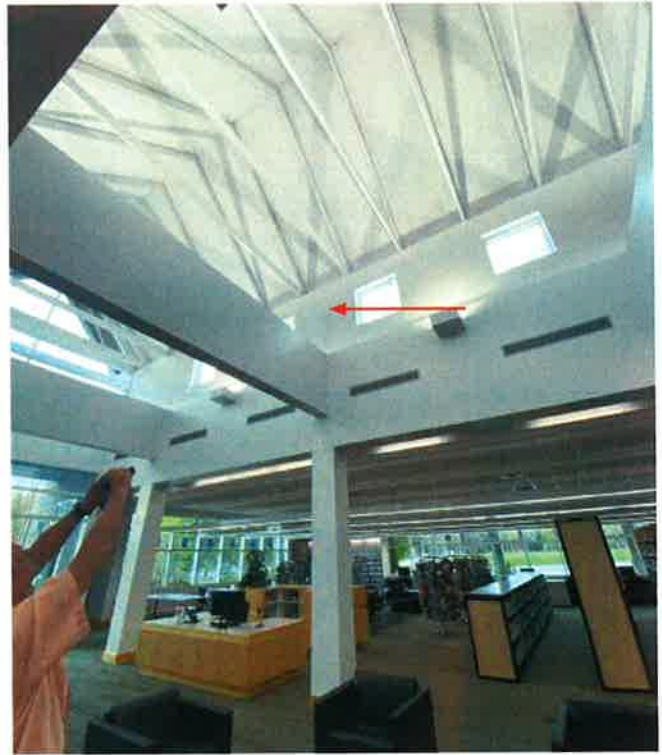
#5. At central skylight, gypsum wall cracking was observed

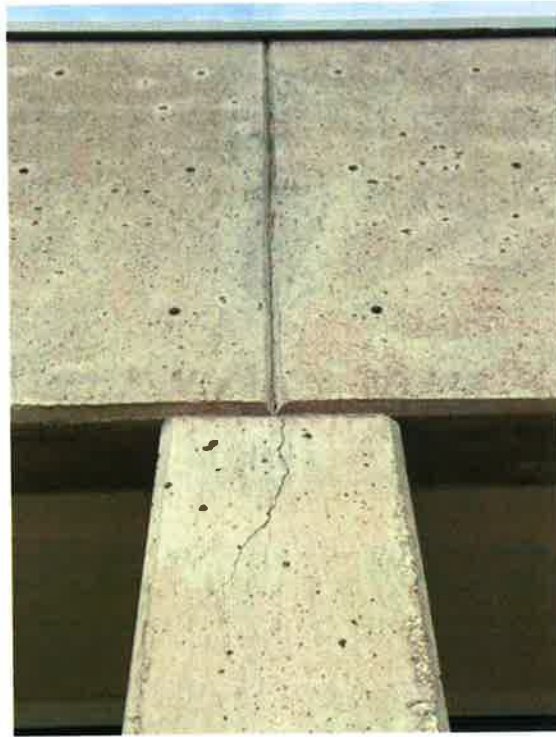
- There are several cracks in the sheetrock walls. It is possible that some of these cracks may have propagated during the seismic event.
- There are several cracks in the exterior concrete columns, beams and foundation walls. It is possible that some of these cracks may have propagated during the seismic event.
- One of the clerestory windows has a crack in it.
- Some lay-in ceiling tiles appear to have moved out of place during the seismic event.

Photo1 – Example of cracks in exterior beams and columns

Based on the limited evaluation and observation completed for the building, it is our opinion that the status of the structure relative to Life Safety has not changed as a result of the seismic event. We recommend that the cracks in exterior concrete beams, columns and foundation walls be sealed so that water does not penetrate the cracks and cause additional long-term deterioration. Cracked windows should be replaced. Cracks in sheetrock walls can be repaired and painted as required.

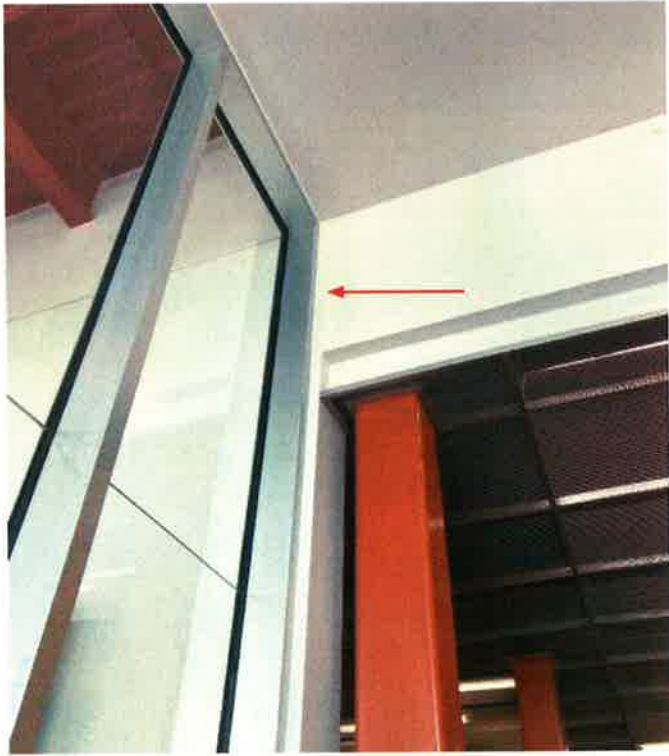
#7. Gypsum board wall cracks

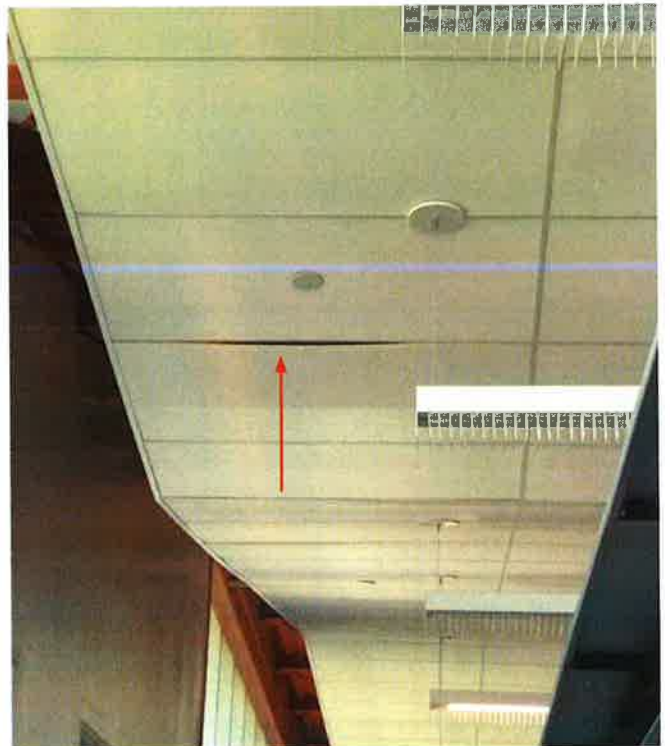
#9. Acoustical ceiling panel displaced from grid

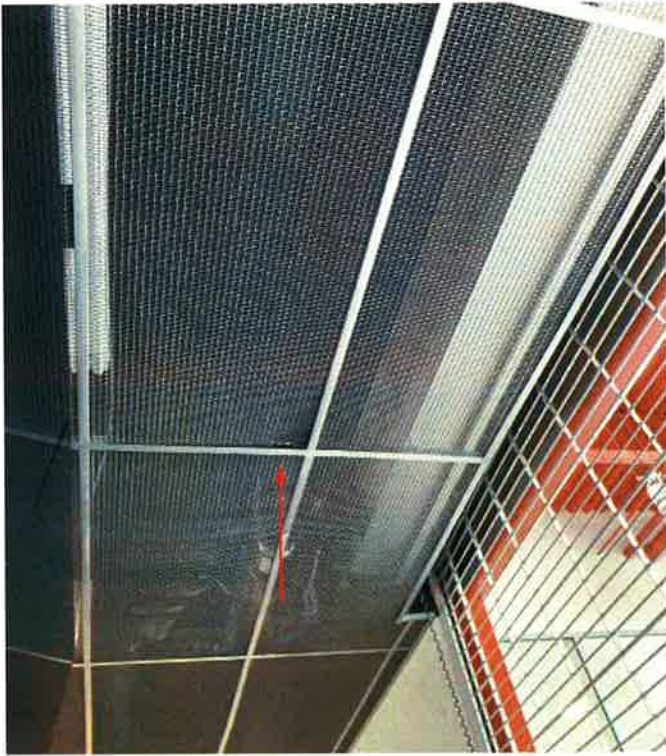
#9. Acoustical ceiling panel displaced from grid

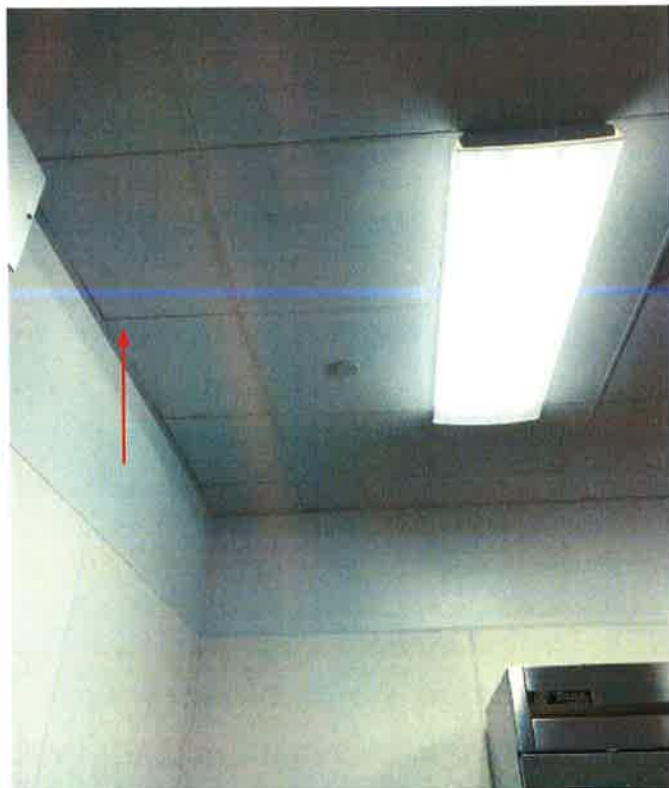
#9. Acoustical ceiling panel displaced from grid

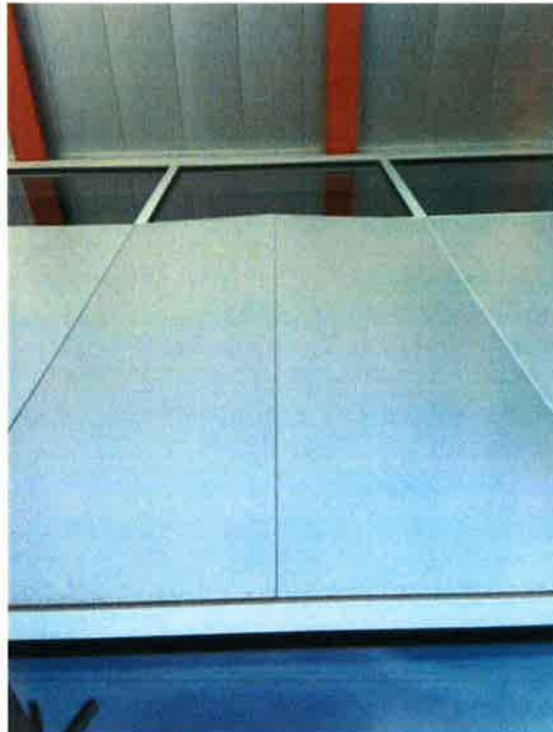
Photo 2 – Example of exterior panel buckling out-of-plane

Based on the limited evaluation and observation completed for the building, it is our opinion that the status of the structure relative to Life Safety has not changed as a result of the seismic event. We recommend that the cracks in non-structural concrete slabs on grade be sawcut and removed (or repaired in place) as necessary. Wall panels can be re-attached as required and cracks in sheetrock walls can be repaired and painted as required.

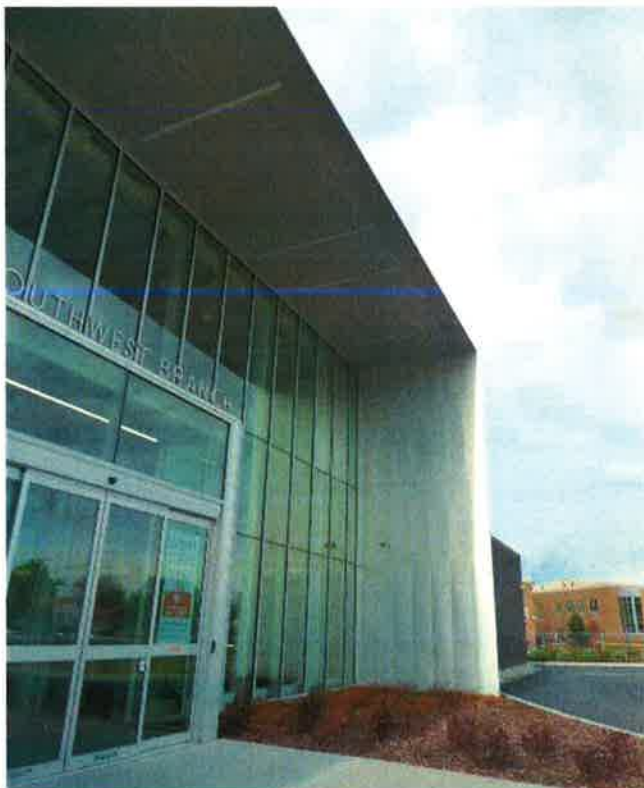
No apparent damage was observed at North entrance

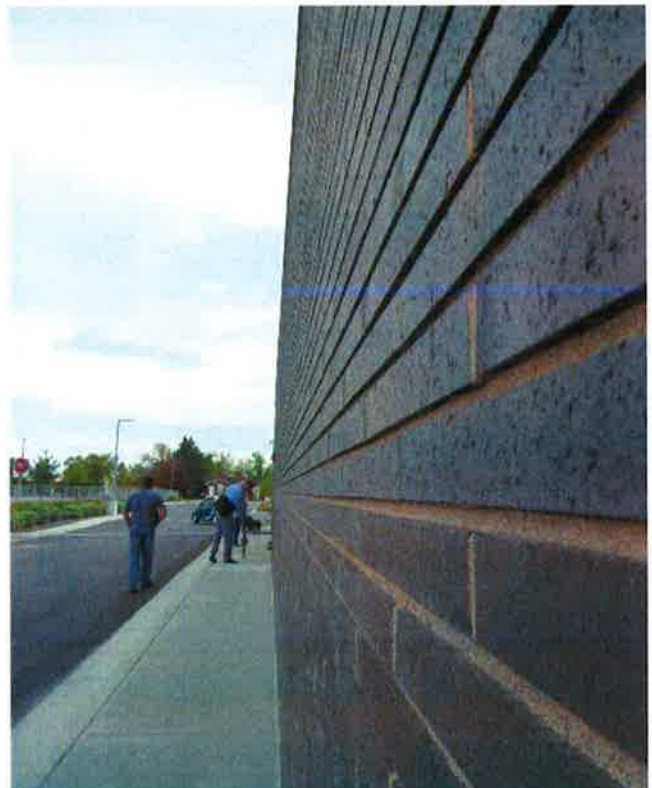
In general, brick masonry appears leveled and without out of plan movement

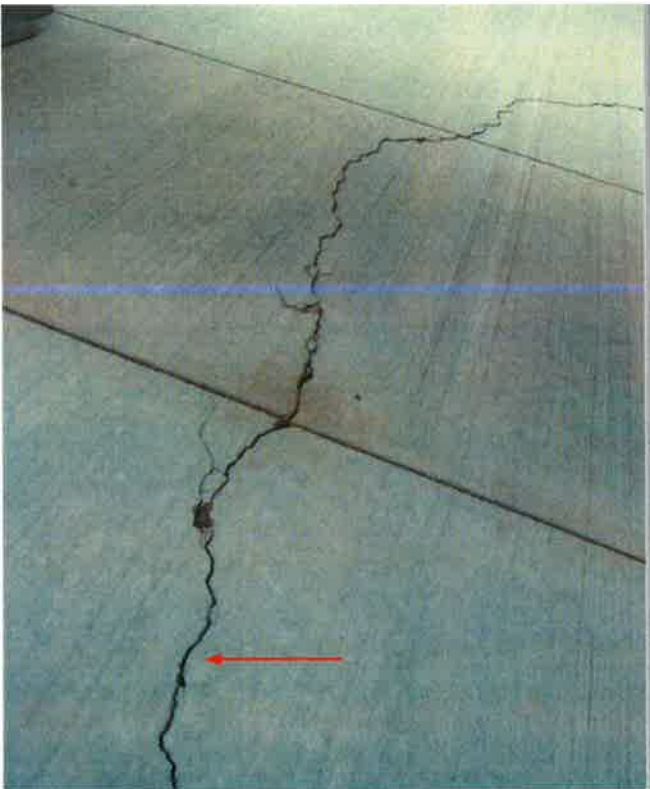
Image 1. The North entrance exterior concrete plaza exhibits cracks in the concrete walkways. Building codes allow up to 1/2" of difference in level. Some spots could soon reach 1/2" if left un-addressed.

#1.Exterior plaza cracking

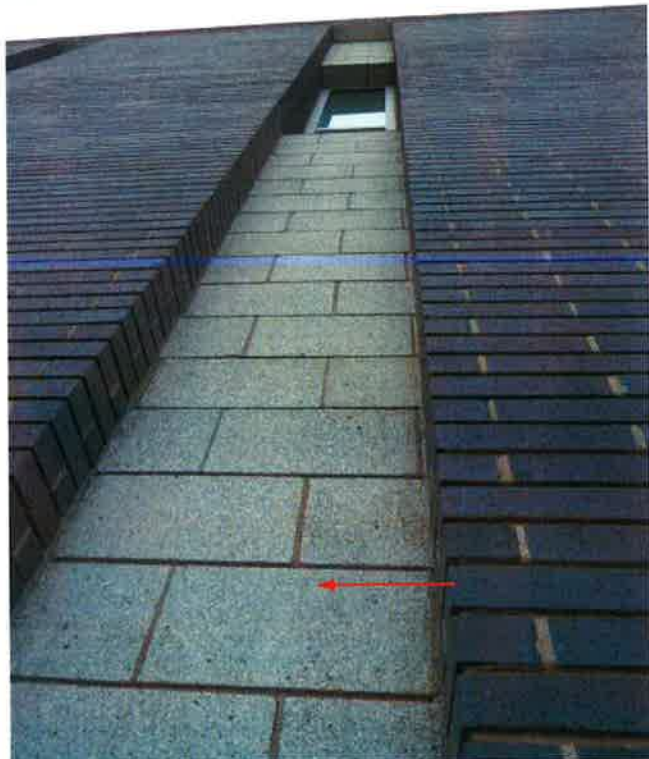
#2. North and East masonry wall cracking.

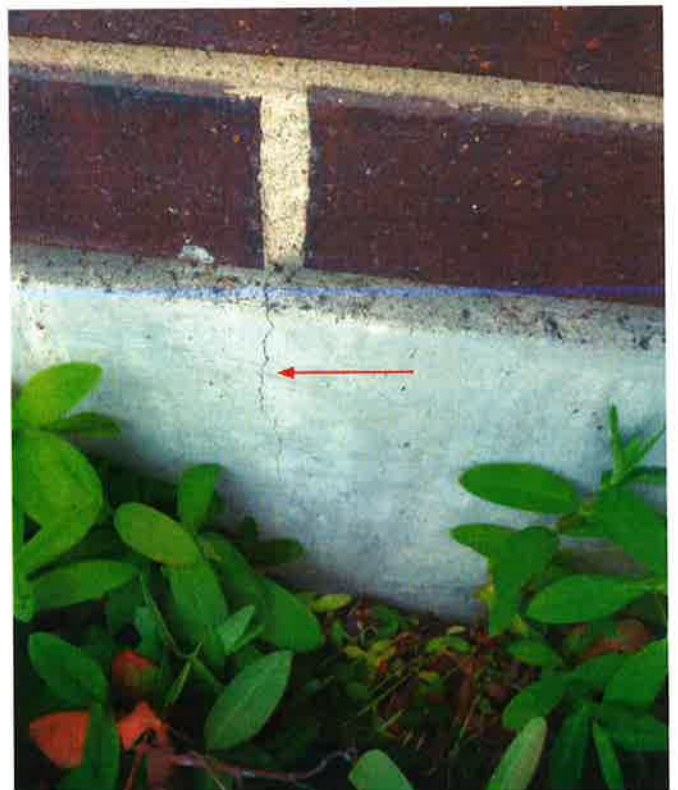
#3. North and East foundation wall cracking.

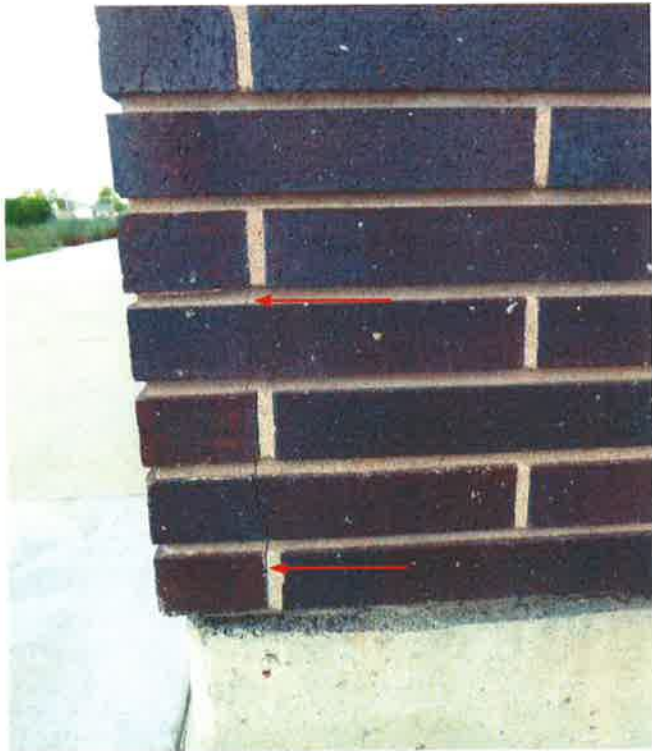
#5. Brick masonry damage.

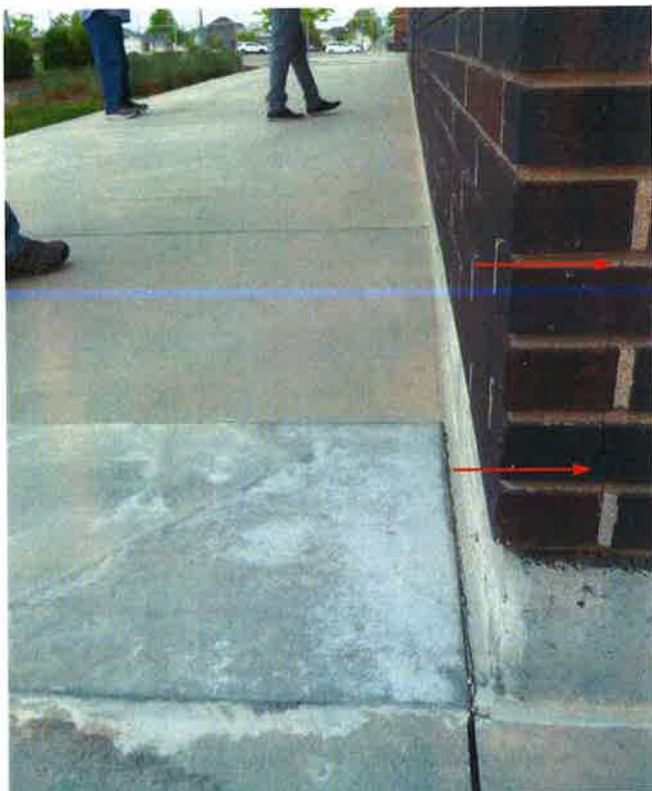
#5. Brick masonry damage.

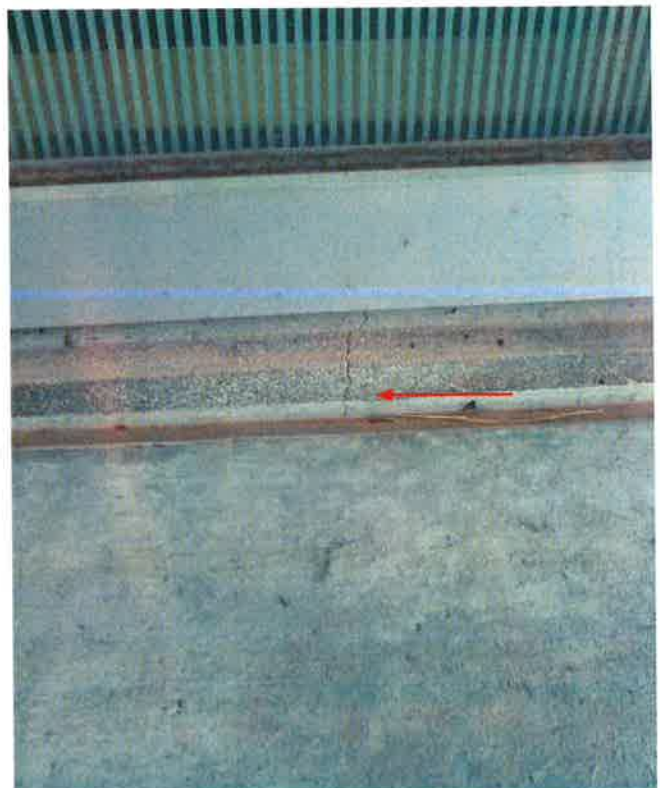
#6. Hairline crack at foundation wall at South Glazing.

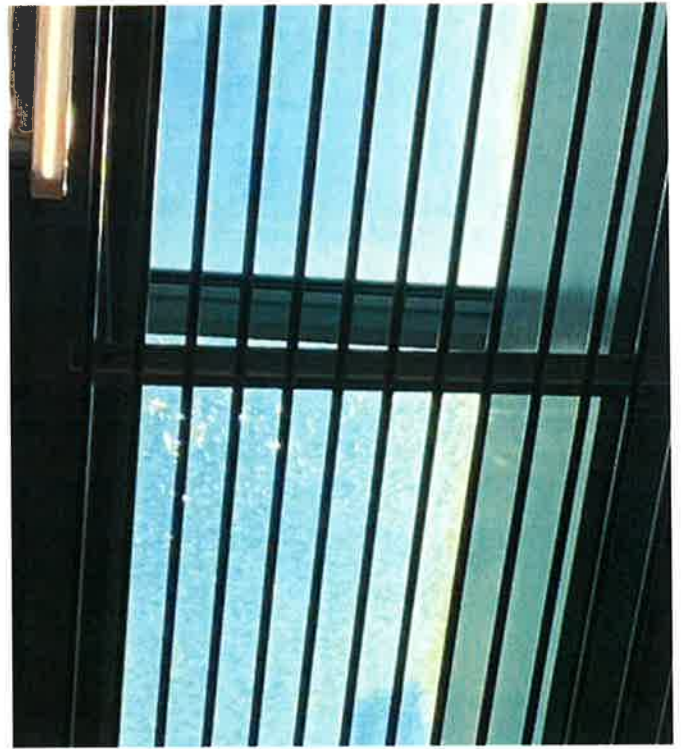
#8. Shattered glass at skylight. View from roof and stacks area.

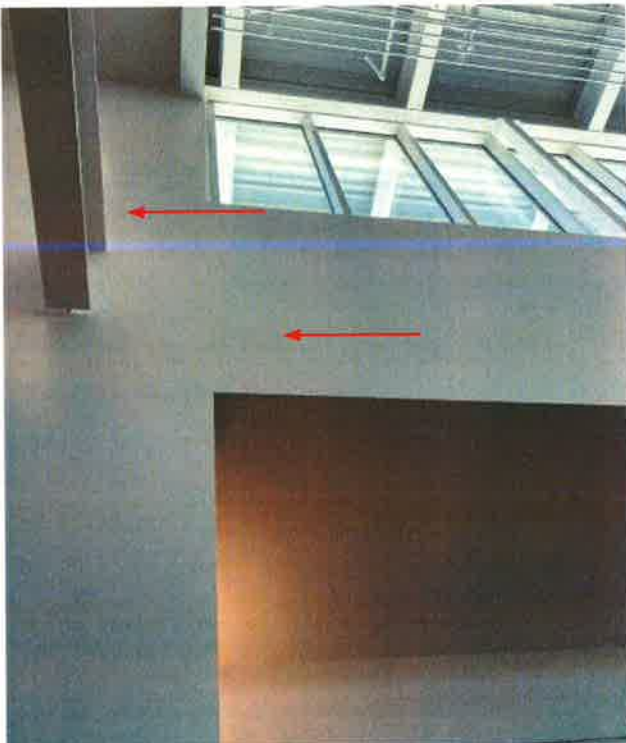
#10 and #11. Painted Gypsum Board wall crack

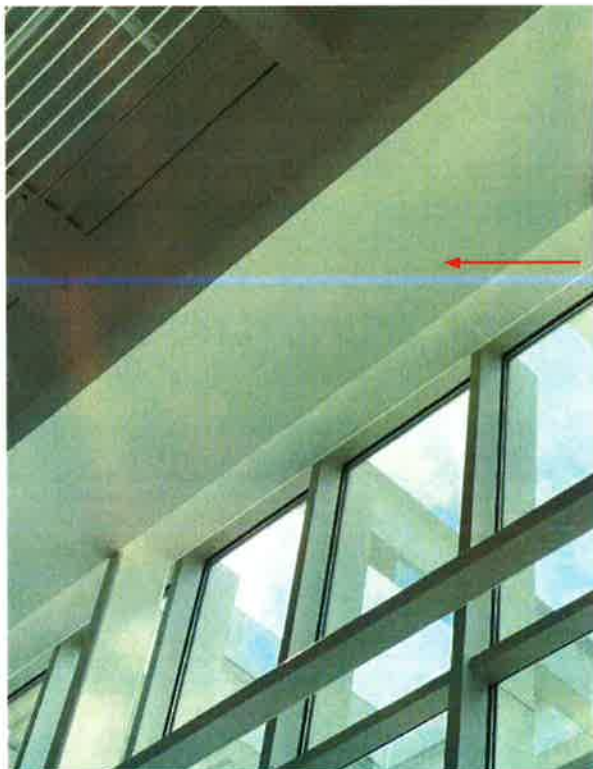
15. Children's Area, Gypsum Board crack

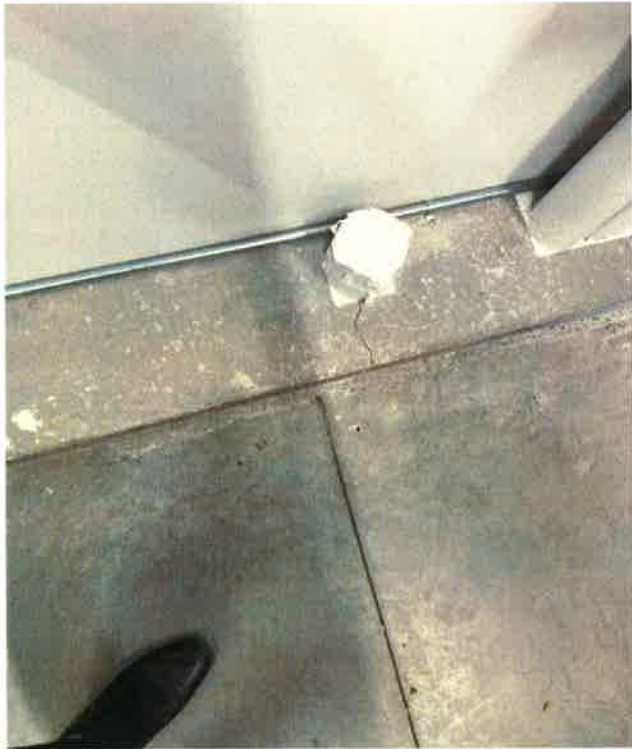
#18. Maintenance Area SR Hall cracks at concrete floor.

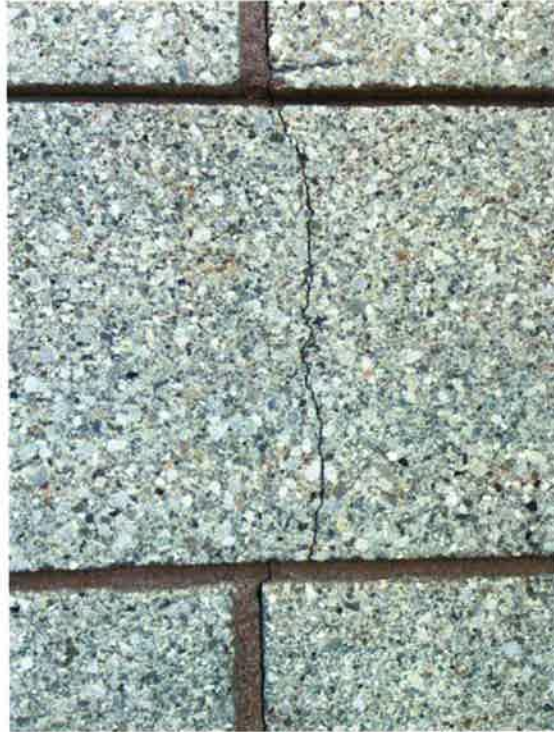
Photo1 – Example of cracks propagating in masonry wall

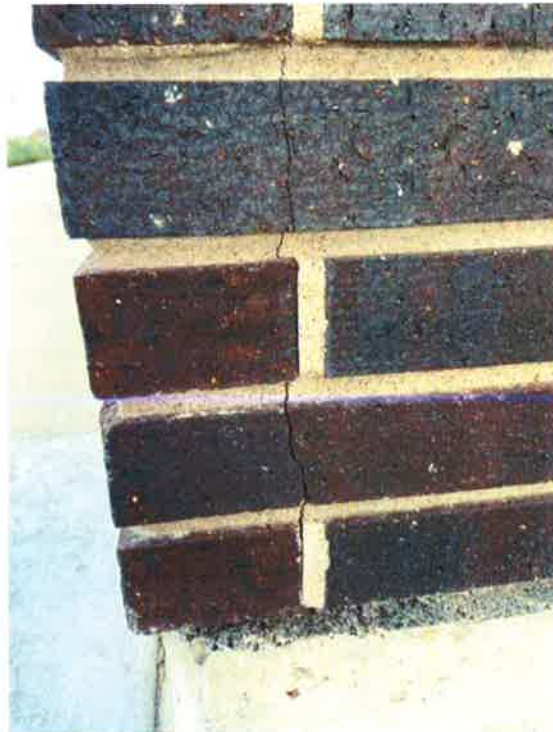
Photo 2 – Example of cracks propagating in masonry veneer

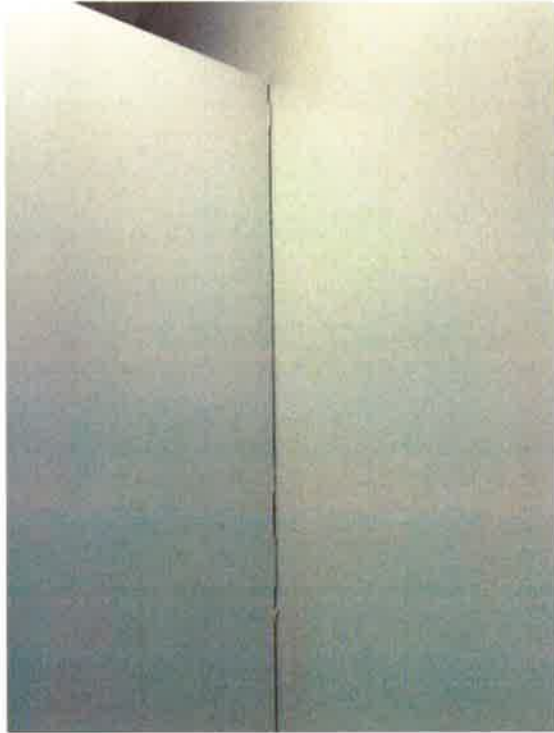
Photo #7 – Example of cabinet pulling away from wall

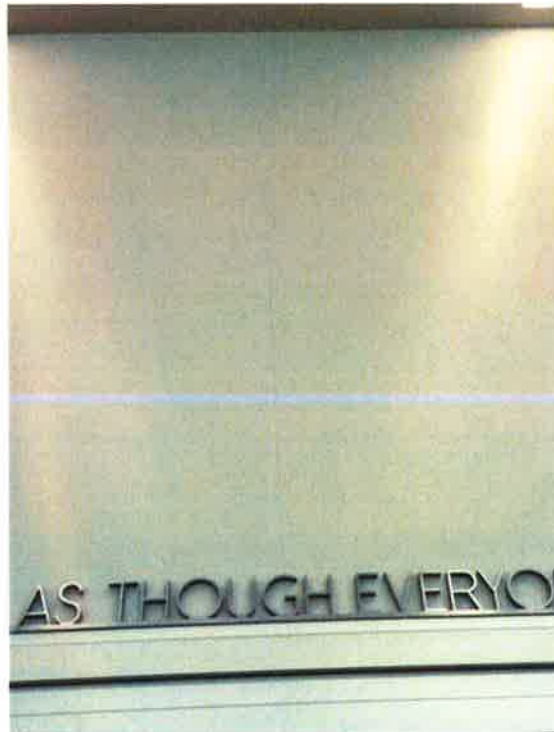
Photo #8 – Example of a crack in the sheetrock wall
