Preparation of drawings and specifications for mitigation of earthquake damage to five  
County Library buildings:

Weber County Main Library;  
Weber County North Branch;  
Weber County Ogden Valley Branch;  
Weber County Pleasant Valley Branch; and  
Weber County Southwest Branch/Headquarters.

## **EARTHQUAKE DAMAGE ASSESSMENT**

**RE:** Earthquake Damage Observation for the Main Library

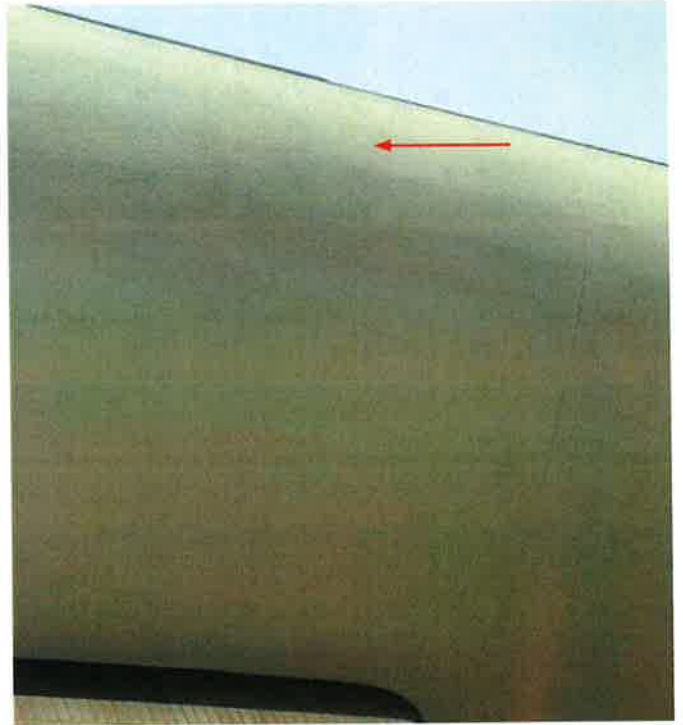
Image 1. At all 4 sides of the building facades, the Plaster soffit exhibits several hairline cracks. This soffit overhangs the public walkways.

#1. Plaster Soffit hairline cracks

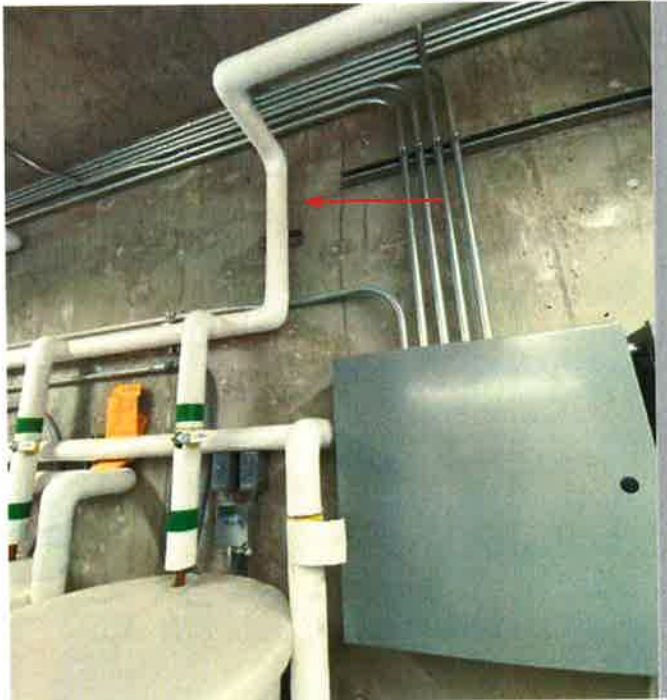
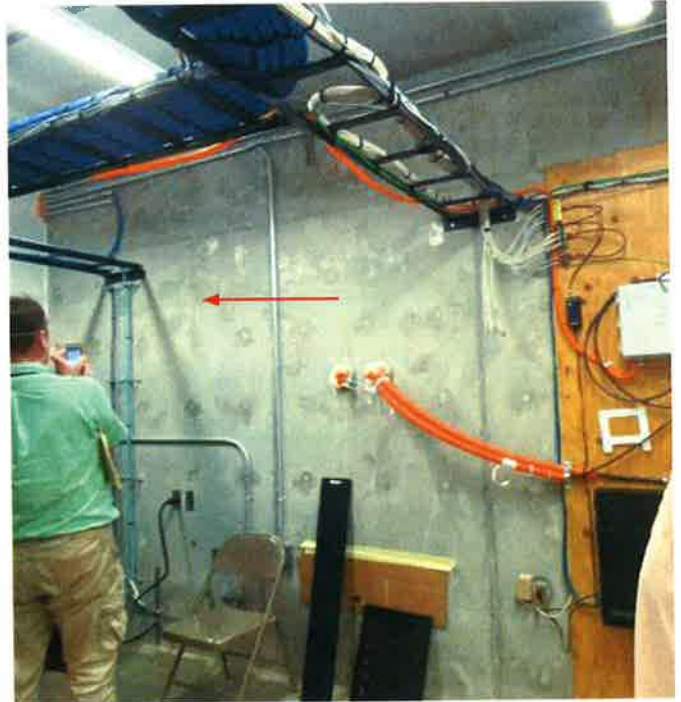
Image 5. On the lower level of the library at the mechanical room, fire riser room, electrical rooms and storage rooms where the building structure is exposed, hairline cracks on the concrete walls were observed.

#5. Concrete wall hairline cracks

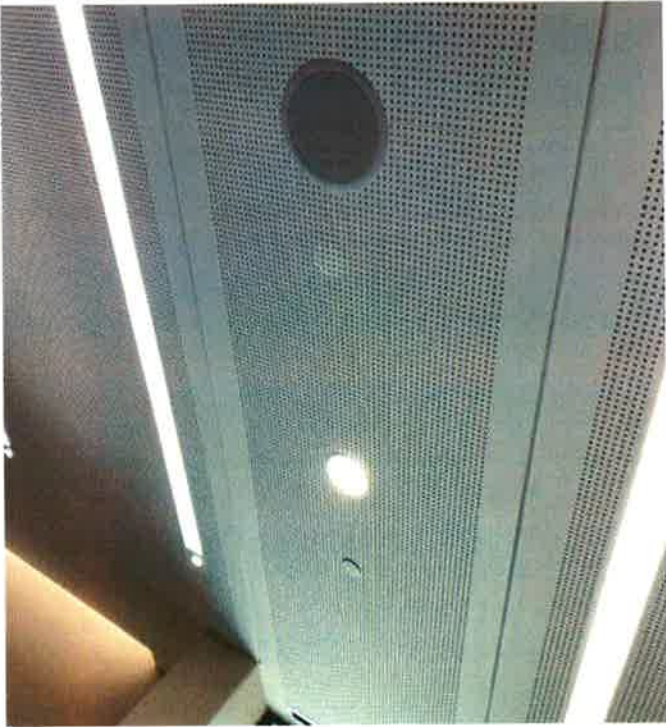
Image 6. At several locations within the building cracking of gypsum board surface was observed at wall corners or wall/ceiling intersections.

#6. Gypsum wall board cracks

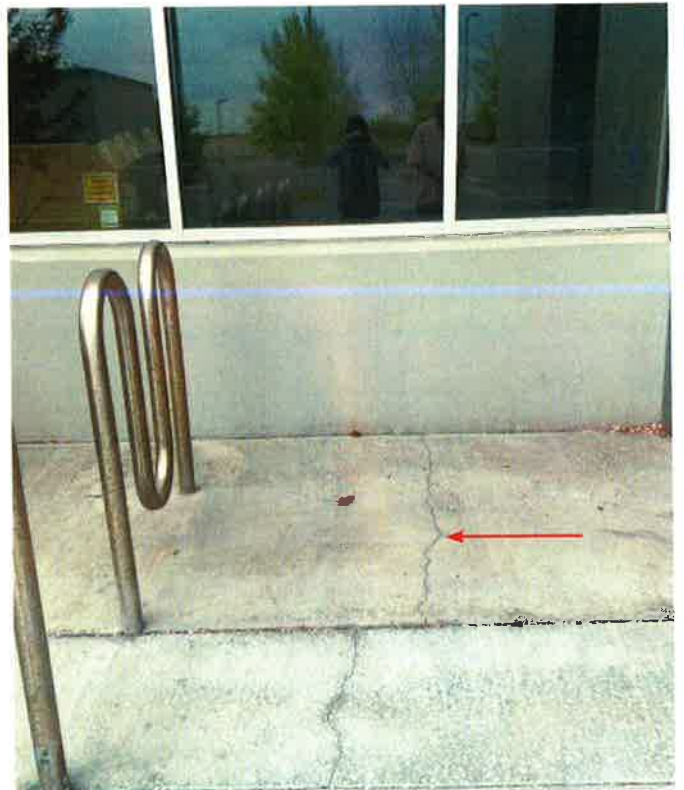
Image 2. The south lower level entrance and patio exhibits fresh hairline cracks to the concrete slab on grade and apparent movement near the glazing.

#2. Lower level South entrance concrete slab cracks

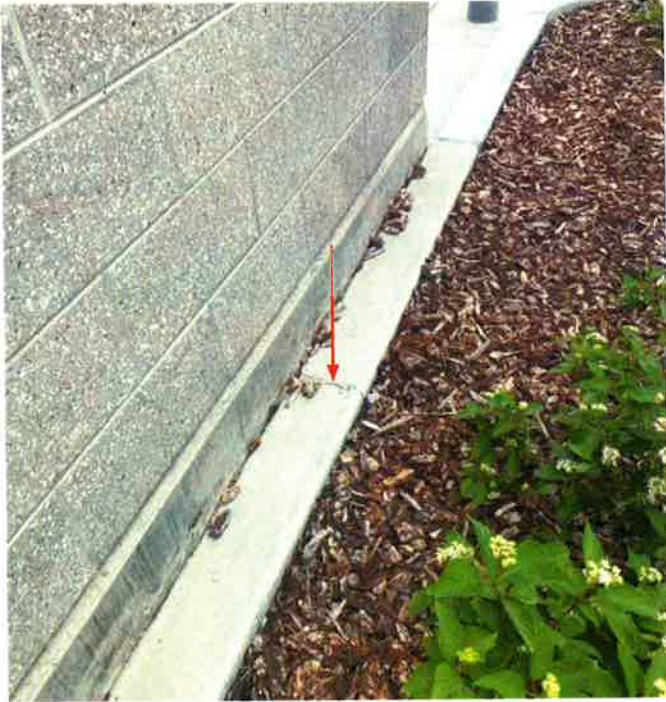
Image 3. The North parking lot, West concrete retaining wall exhibits several cracks along the face of the wall and a large break at the top of the wall, at the connection of one of the railing posts.

#3 Retaining concrete wall cracks

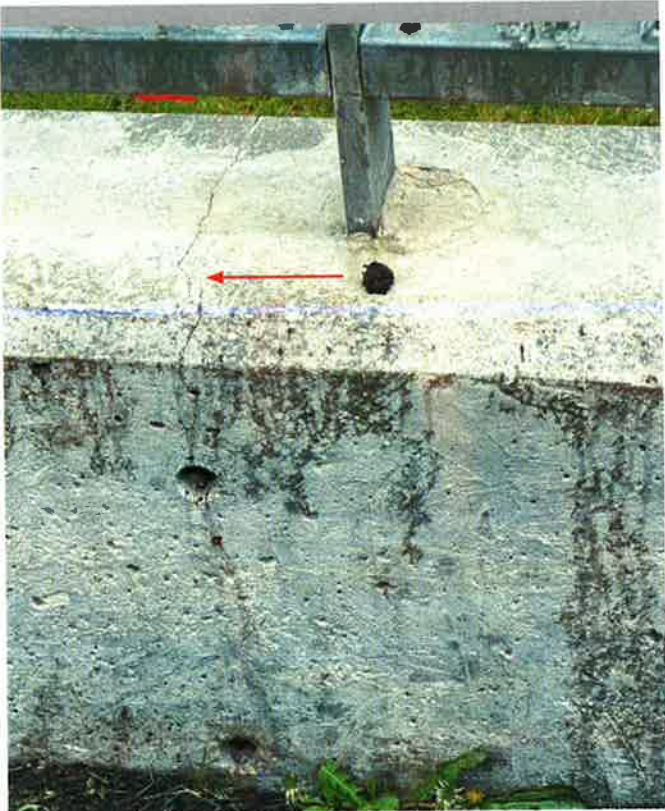
#1. Concrete walls hairline cracks

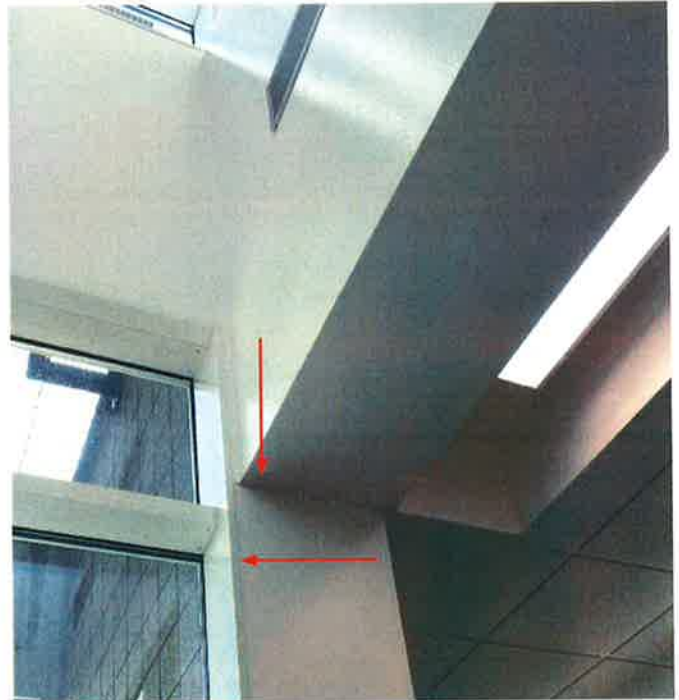
#3. Hairline crack at painted gypsum wall surface

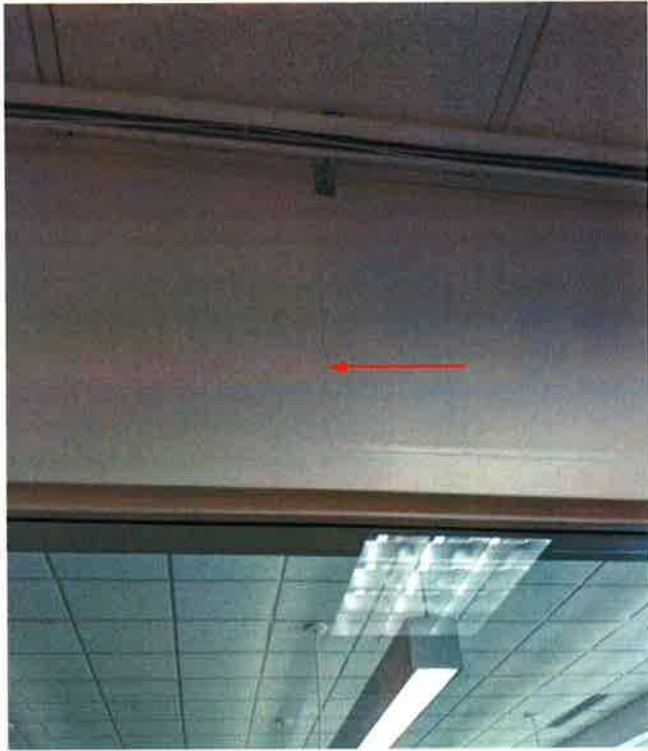
#5. At central skylight, gypsum wall cracking was observed

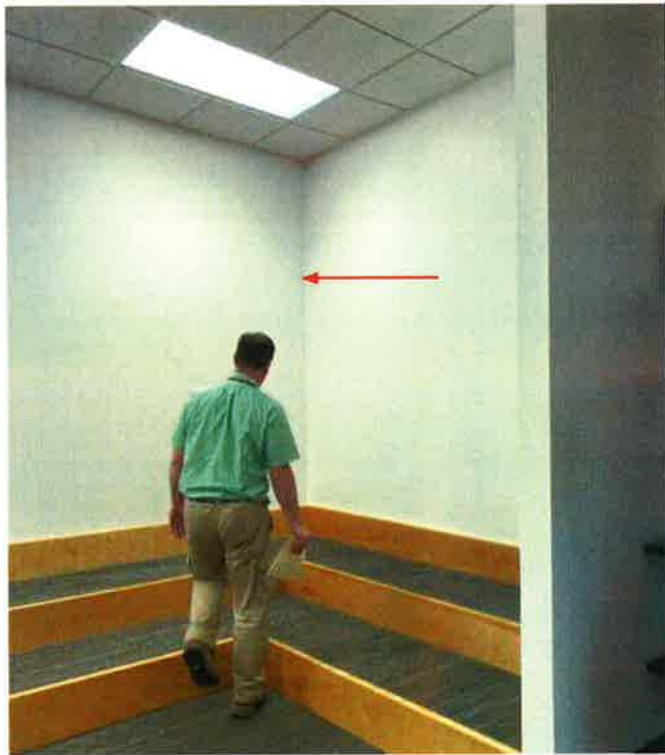
#6. The Children's Area exhibited gypsum board wall cracking

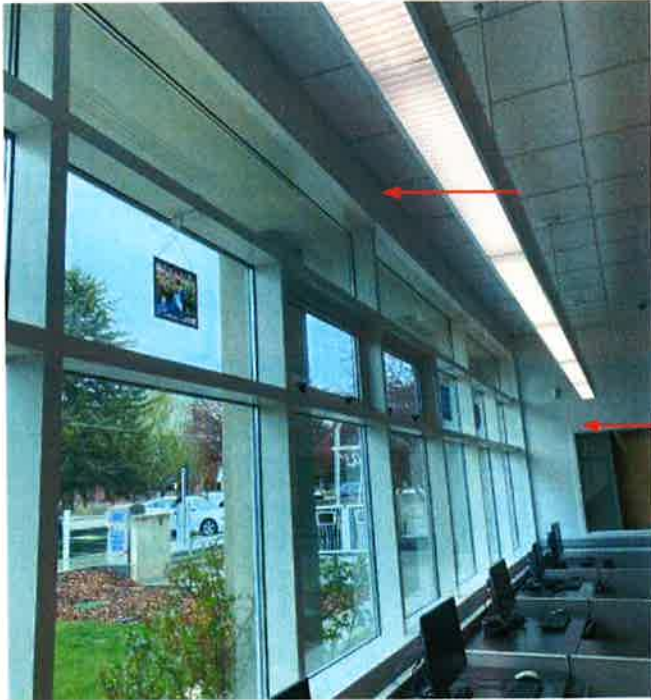
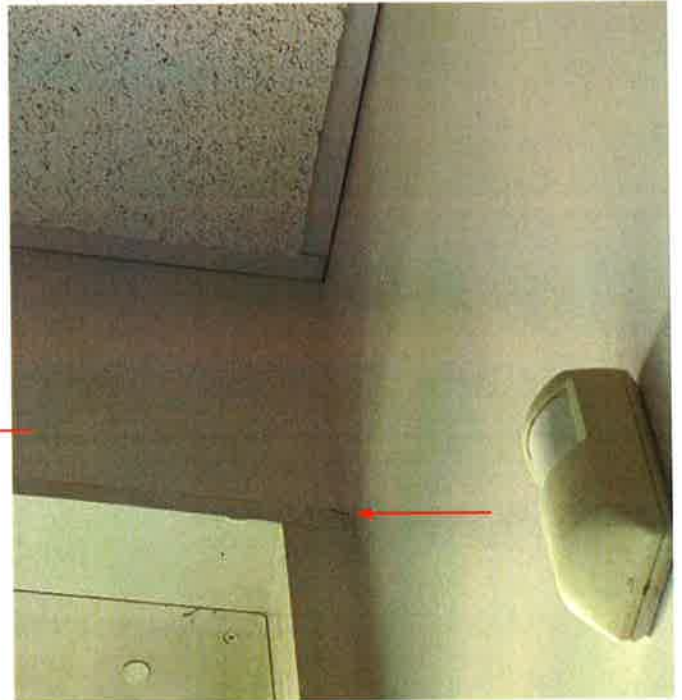
#7. Hairline crack at painted gypsum wall surface

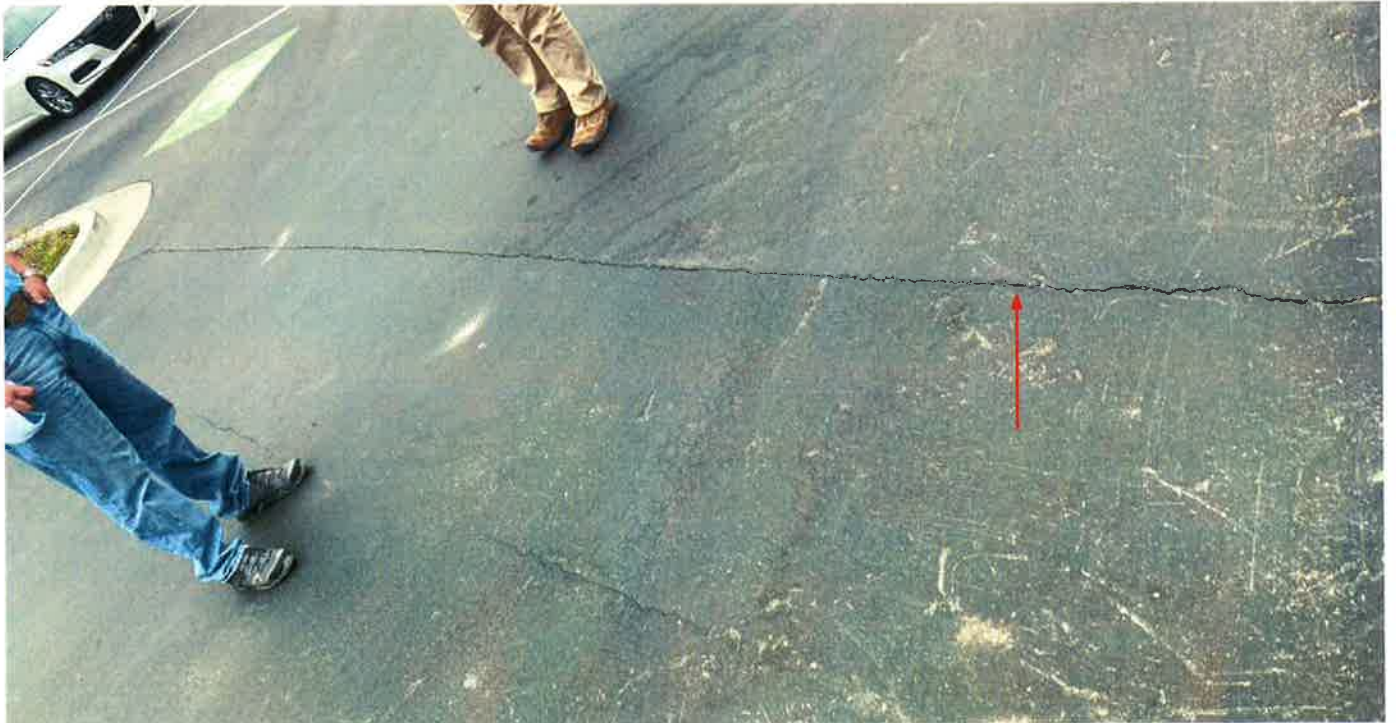
Image 1. The North parking lot shows a significant crack near the entrance main building.

# 1. Asphalt surface crack at parking lot

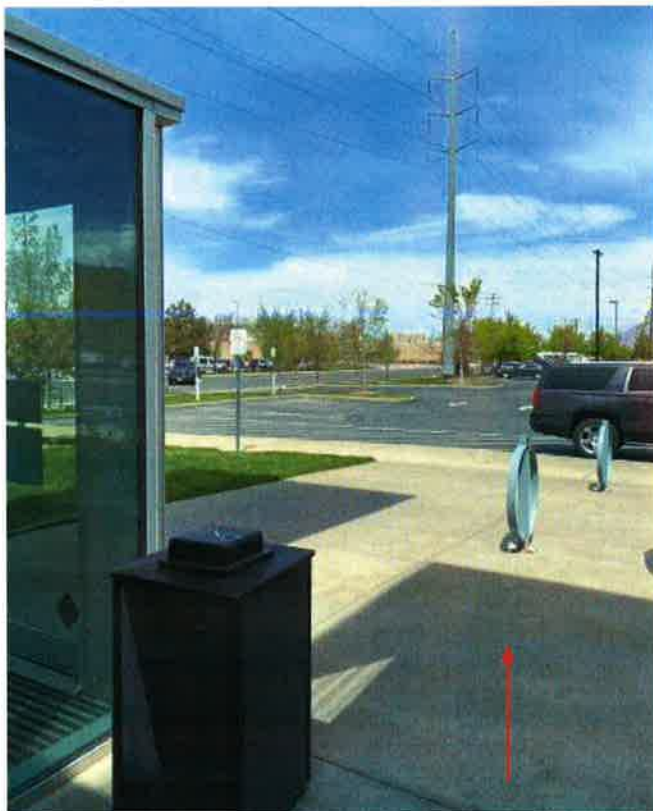
Brick and CMU does not show sign of damage

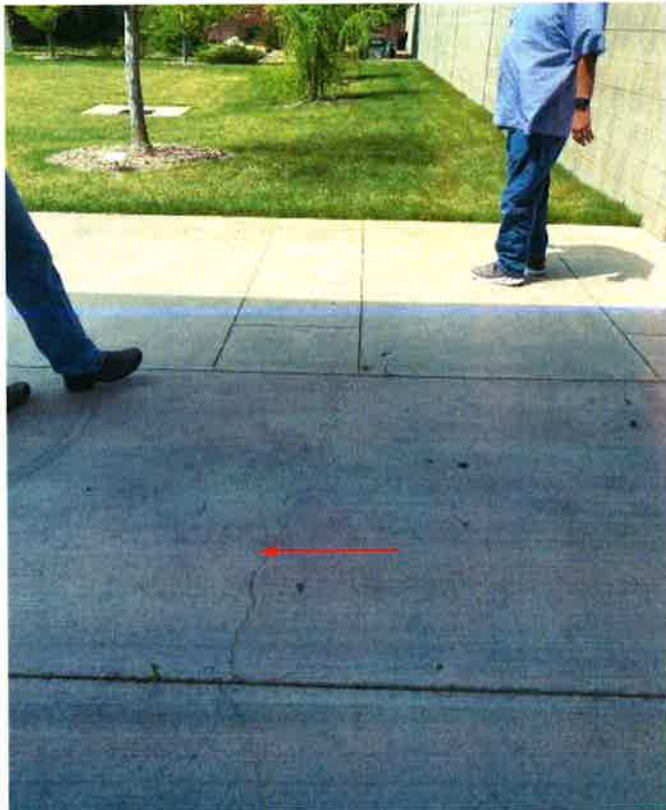
Image 2. The North entrance exterior concrete walkway exhibits cracks in the concrete.

#2. Cracks at entrance walkway concrete slab on grade

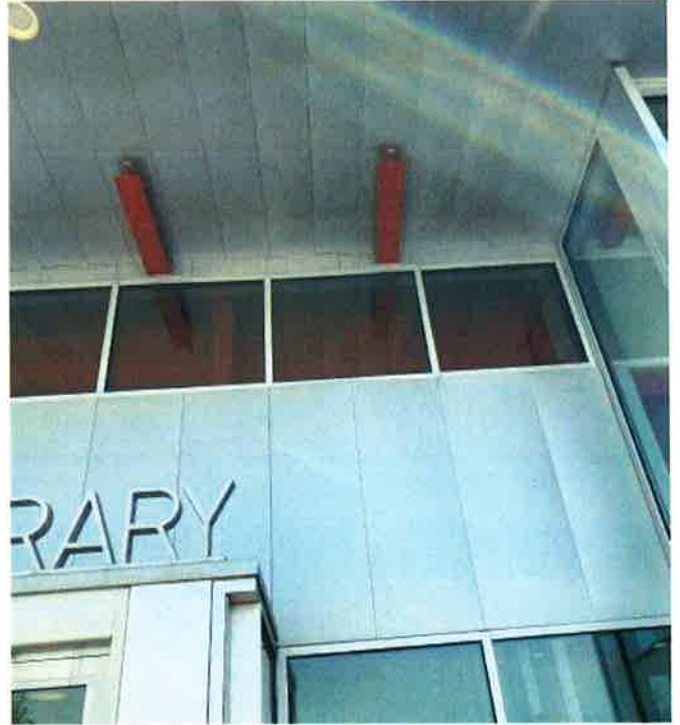
3. North Entrance does not exhibit damage.

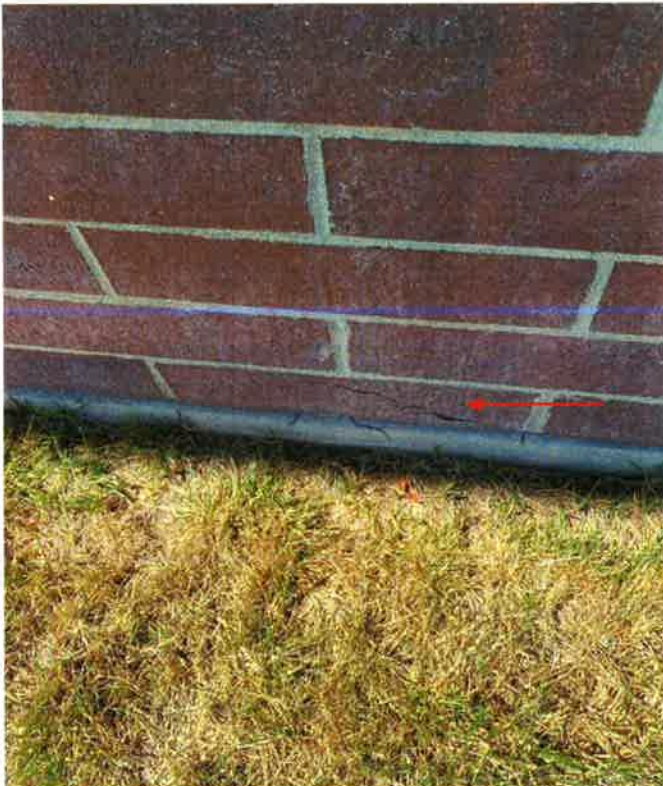
Image 4. On the North Façade, one area shows damage to the brick masonry and the concrete foundation wall.

#4. North facade brick masonry and foundation wall damage

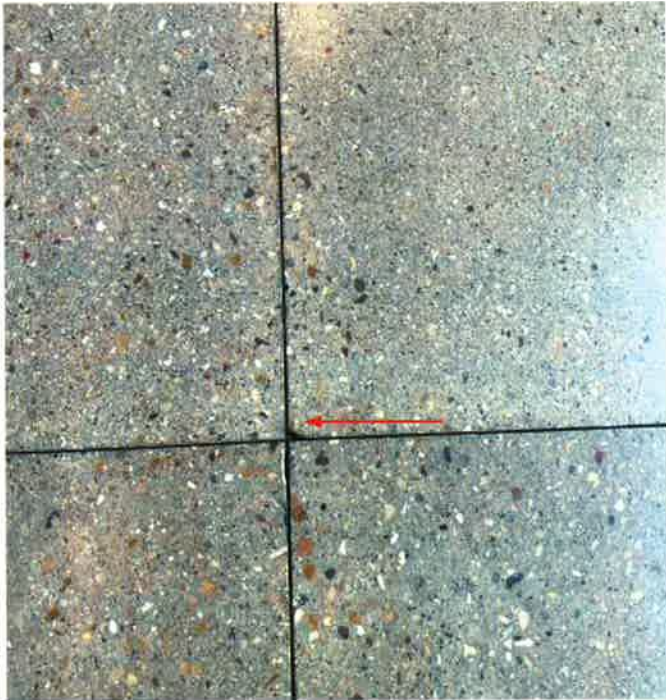
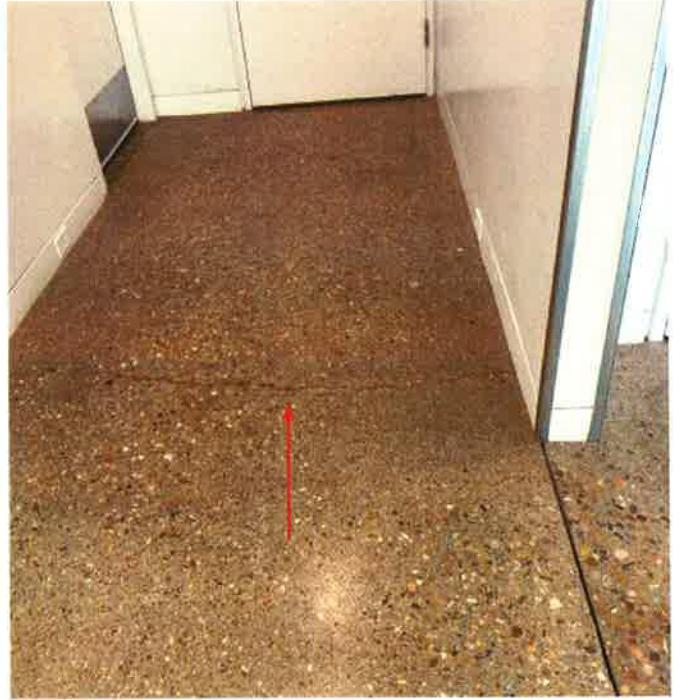
The building appears to have experienced movement of surfaces in some interior walls, but most visible in the concrete floors. The life safety systems of the building do not appear compromised. If left un-addressed, the concrete floors damage may widen or their edges may break causing tripping hazards. Furthermore, all exterior damage such as the paving cracks in the public plaza and cracks on the exterior walls should be addressed to prevent further damage and deterioration caused by moisture infiltration and the freeze-thaw cycle process typical to Utah's climate.

#6. Concrete floor cracks

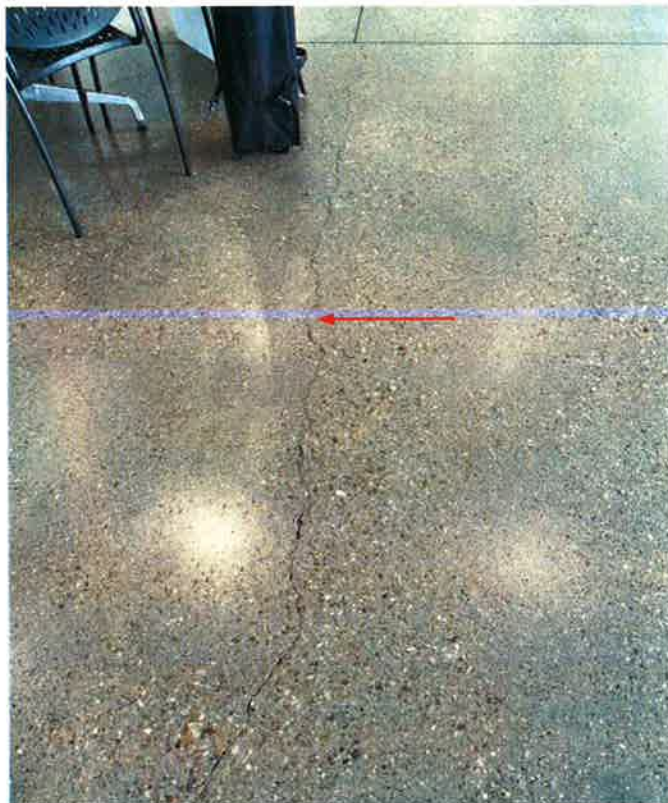
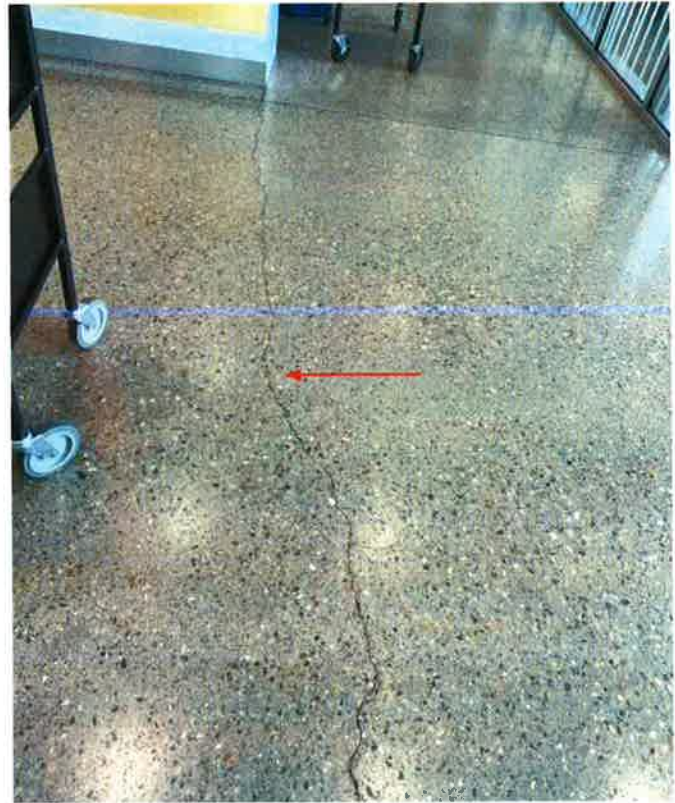
#6. Concrete floor cracks at public circulation areas

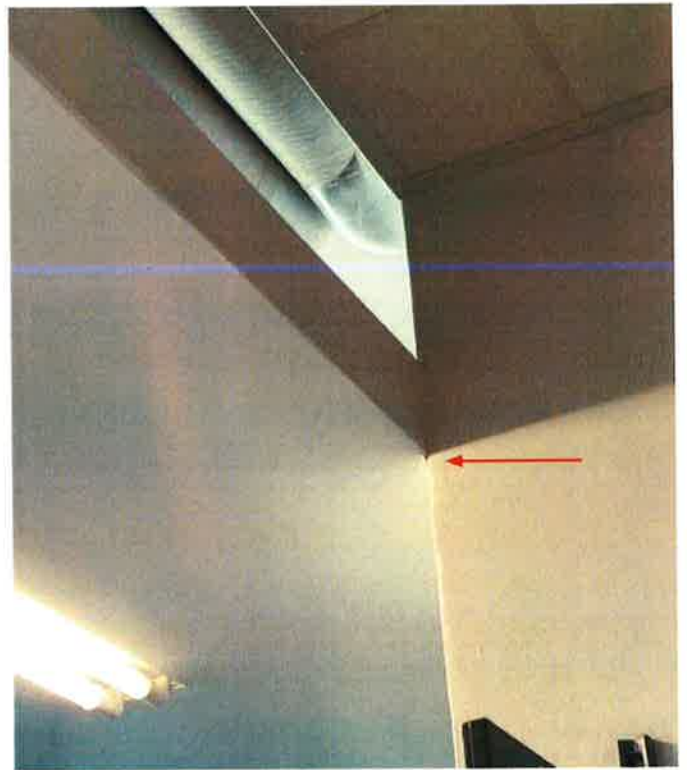
#7. Gypsum board wall cracks

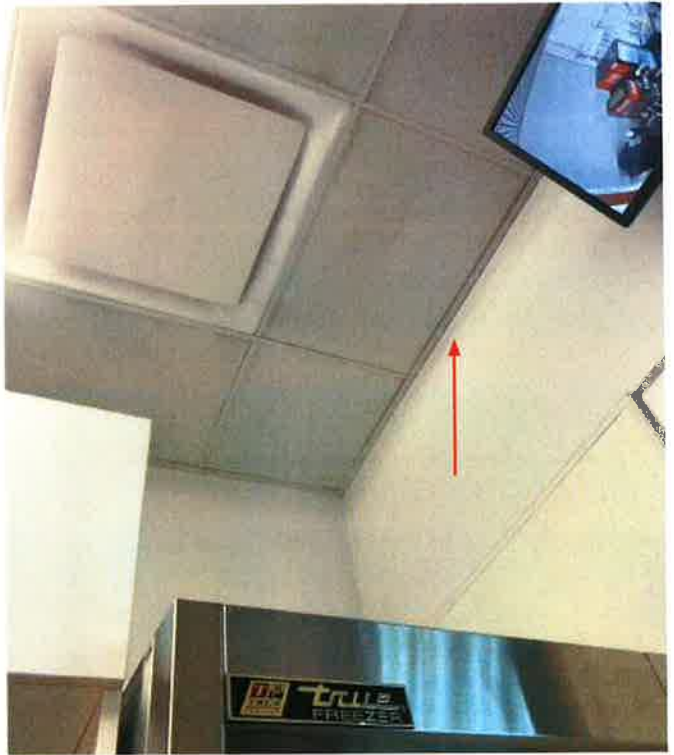
#9. Acoustical ceiling panel displaced from grid

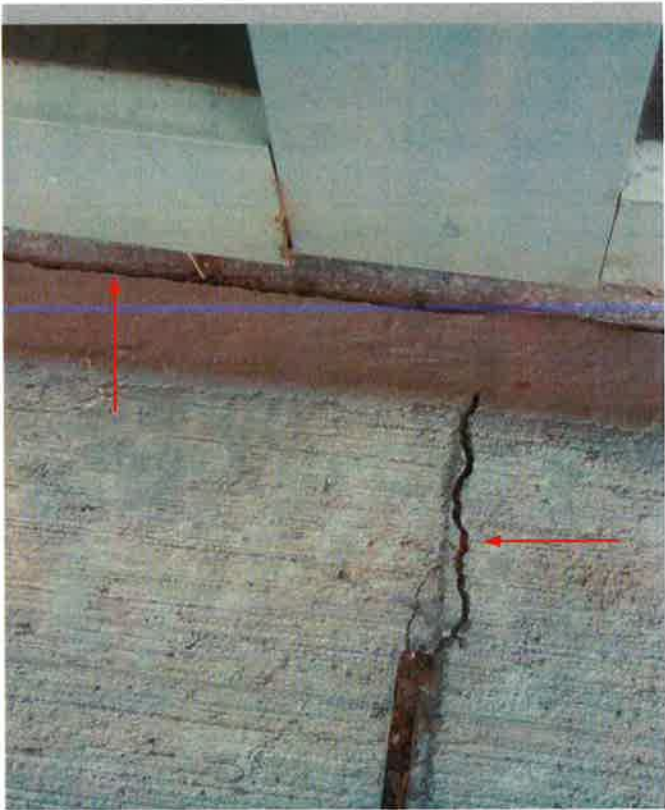
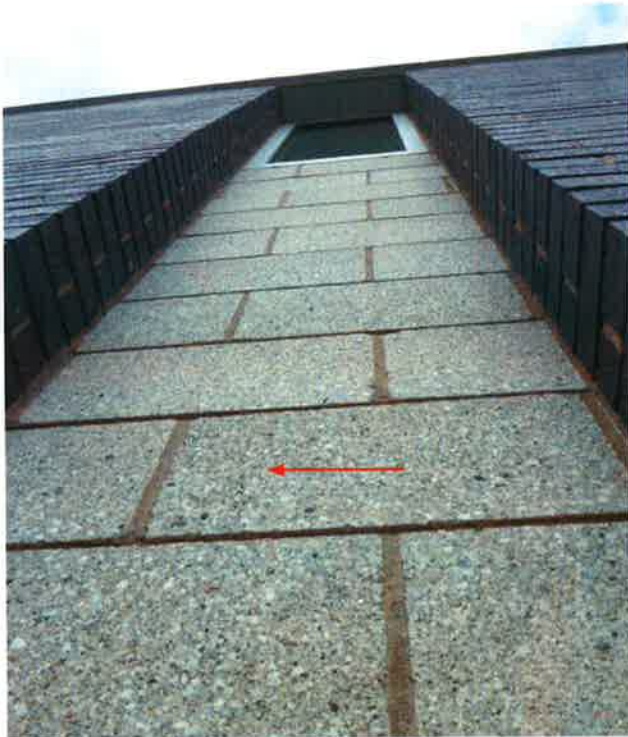
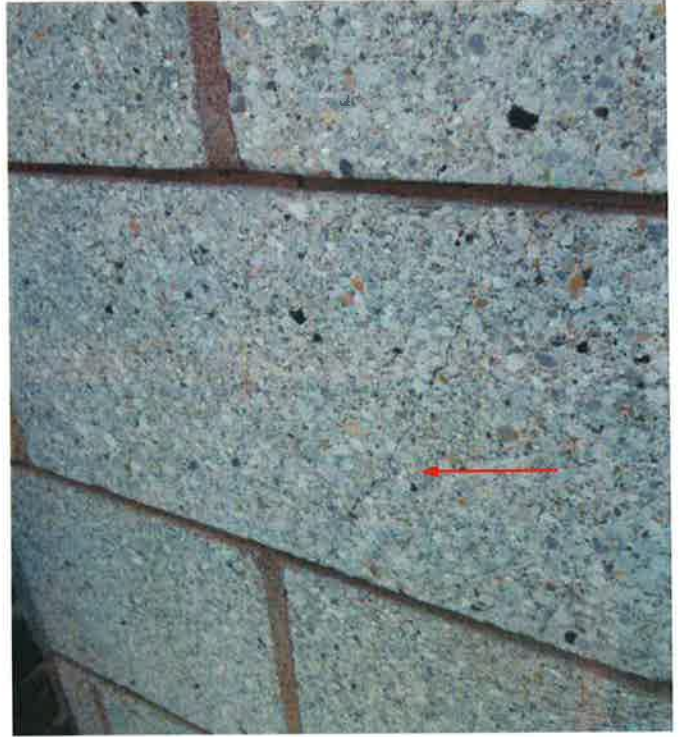
Image 2. The exterior North Facade and East Facade concrete masonry unit (CMU) reliefs within the Brick Masonry wall exhibit hairline cracks. Some hairline cracks extend to the foundation wall.

#2. Hairline cracking at CMU Walls: North and West Facades

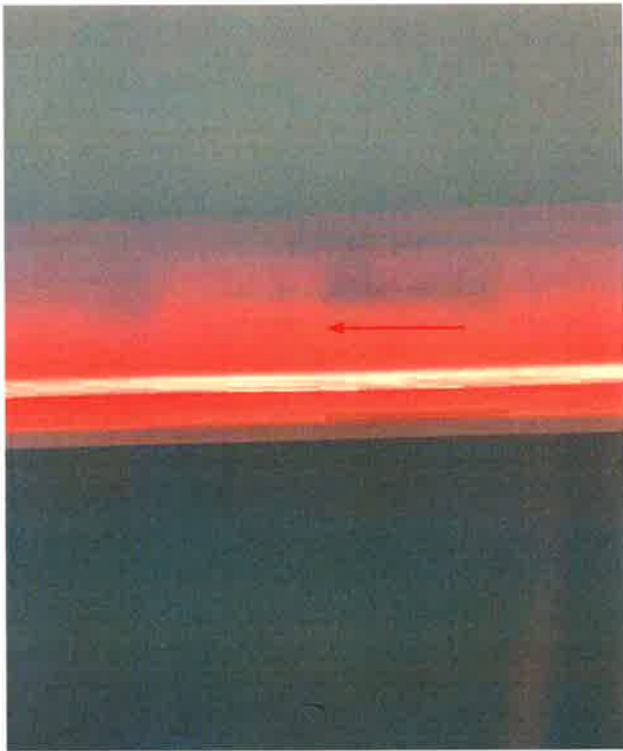
#13. Kitchen ceiling tiles surface cracking and shifting from ceiling grid
